2020 REPORT 4

BIGHORN RIVER CHANNEL MIGRATION ZONE MAPPING

January 2021

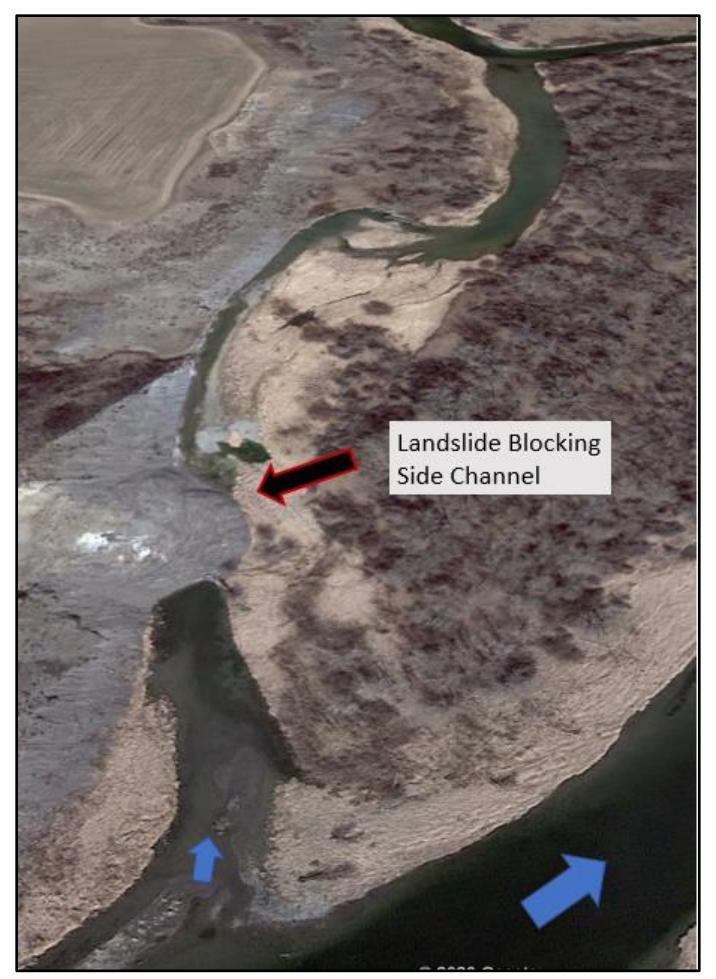
Figure 9. Google Earth (2016) image showing side channel blocked by landslide at RM 56.7.

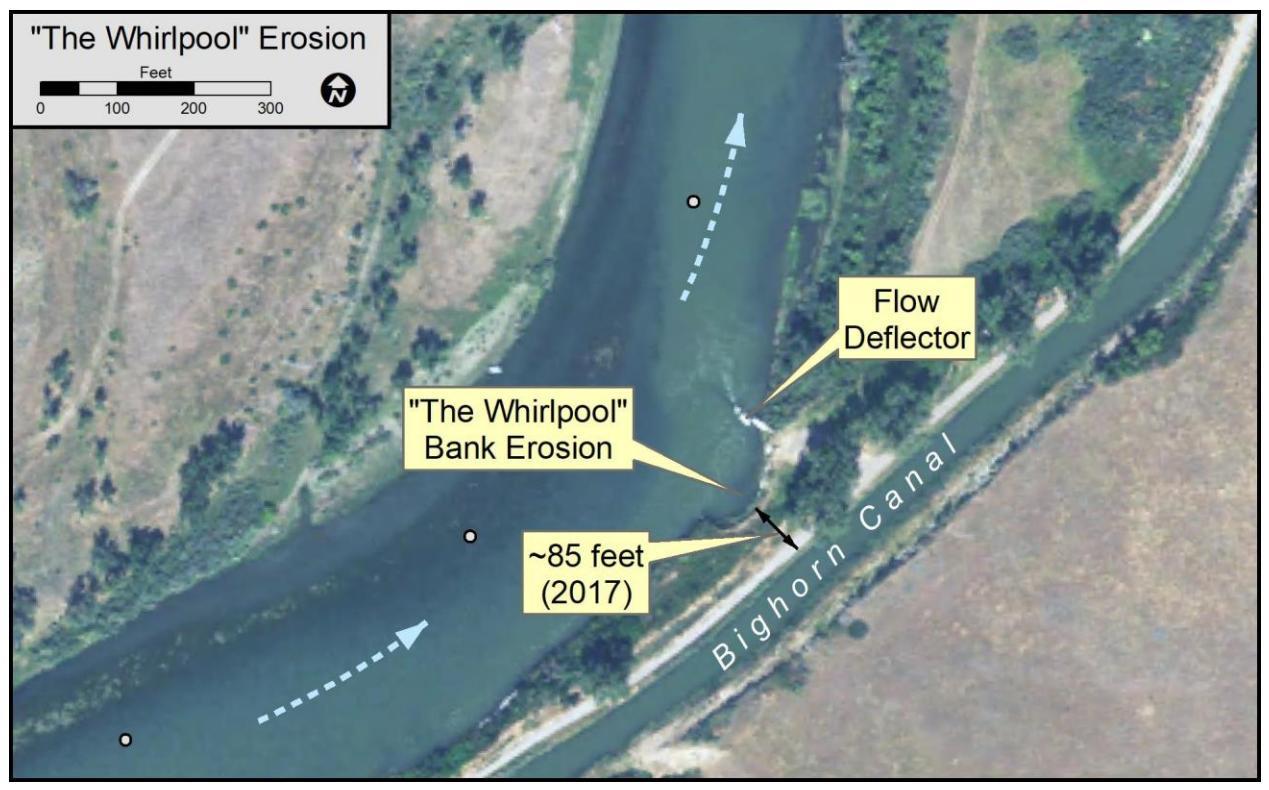
Figure 43. 2017 air photo showing scour upstream of flow deflector; back eddy has eroded the bank towards Bighorn Canal.

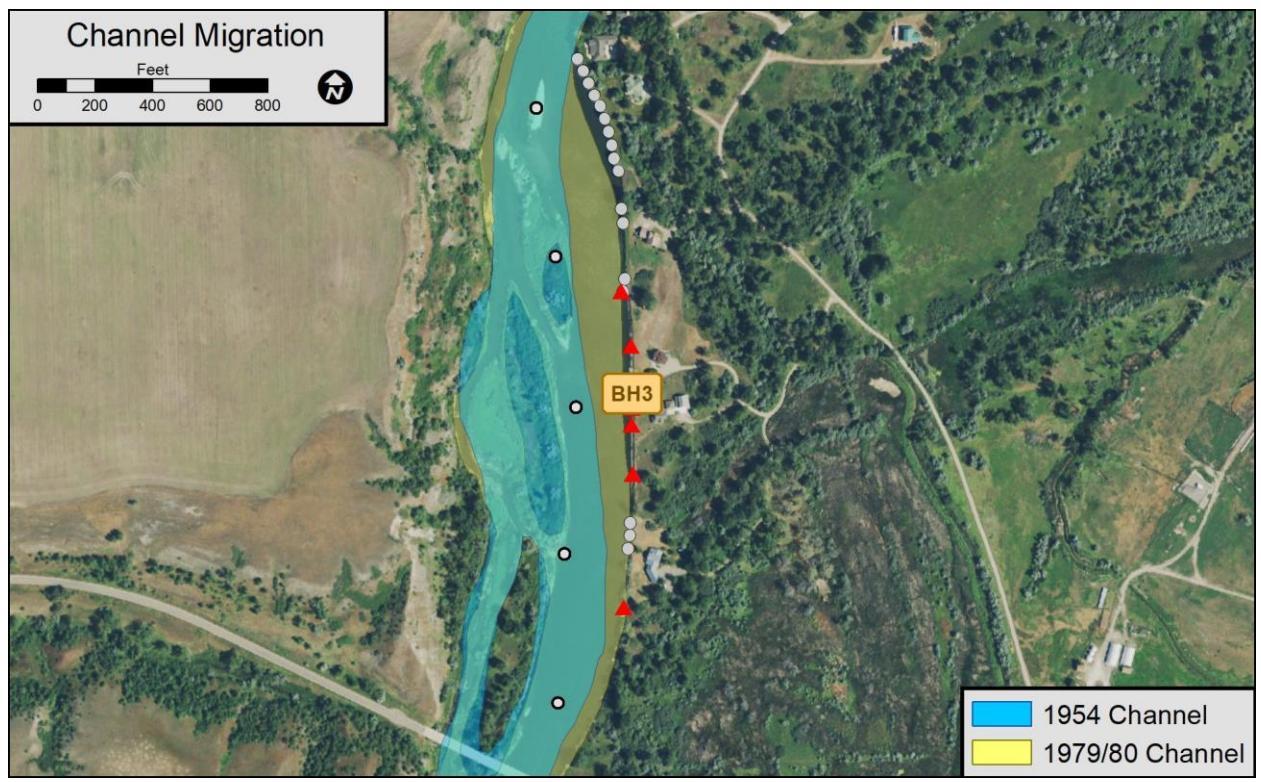
Figure 53. Right bank erosion threatening homes below St. Xavier Bridge.

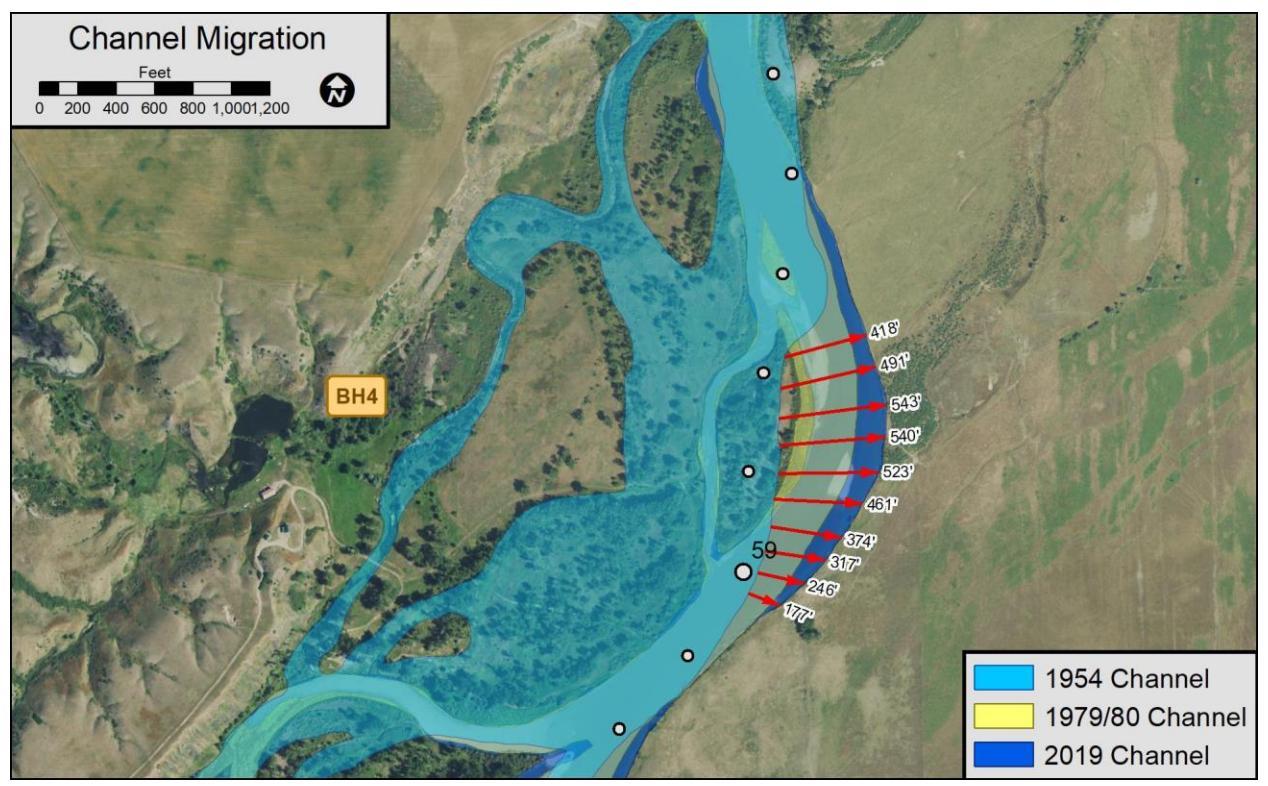
Figure 57. Right bank meander migration into unvegetated bankline, RM 58.9.

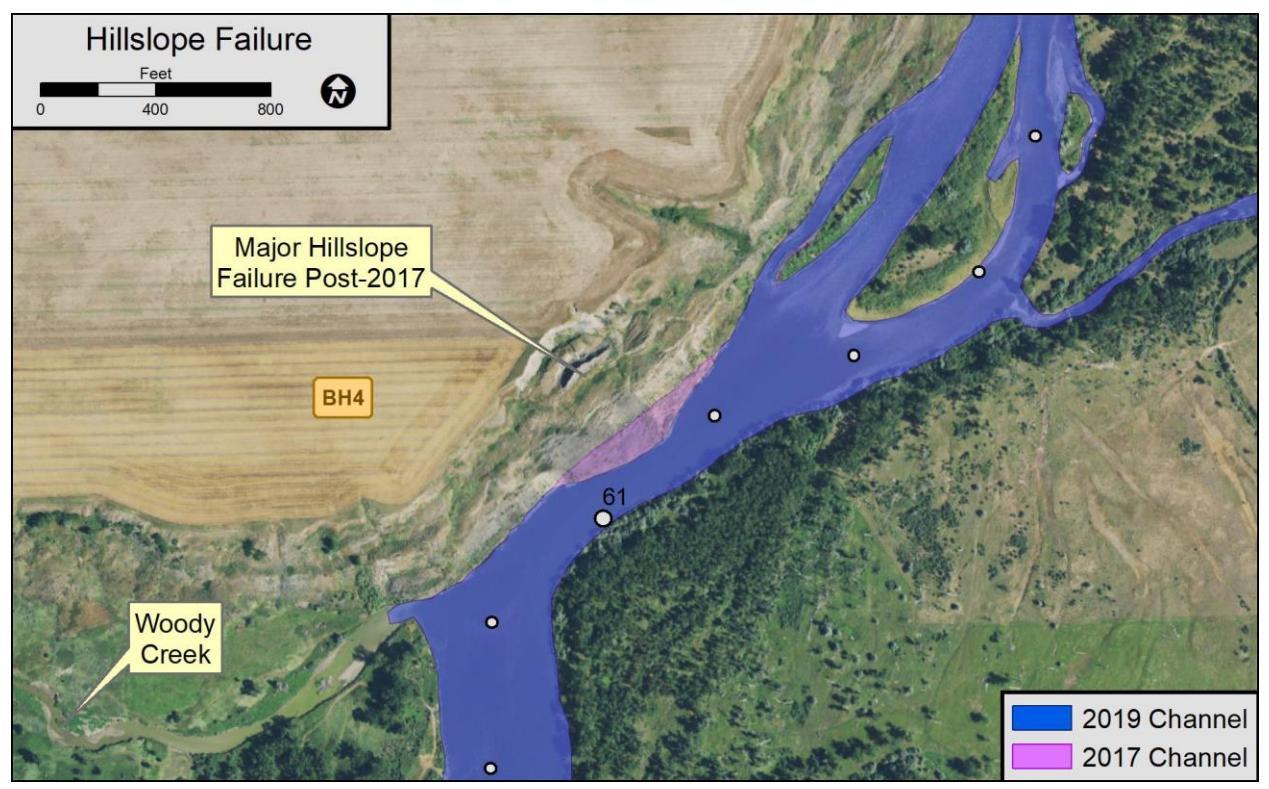
Figure 58. Recent landslide just below Woody Creek RM 61.

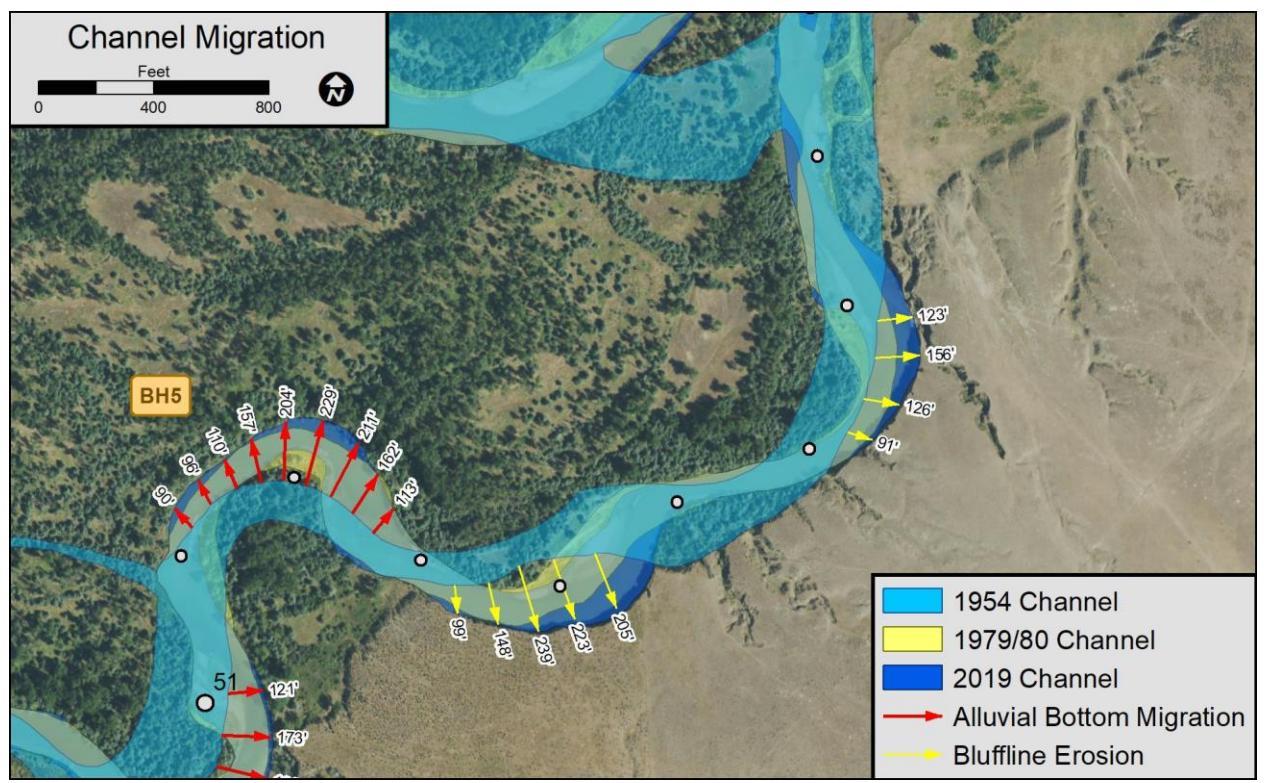
Figure 59. Terrace erosion at RM 50.6.

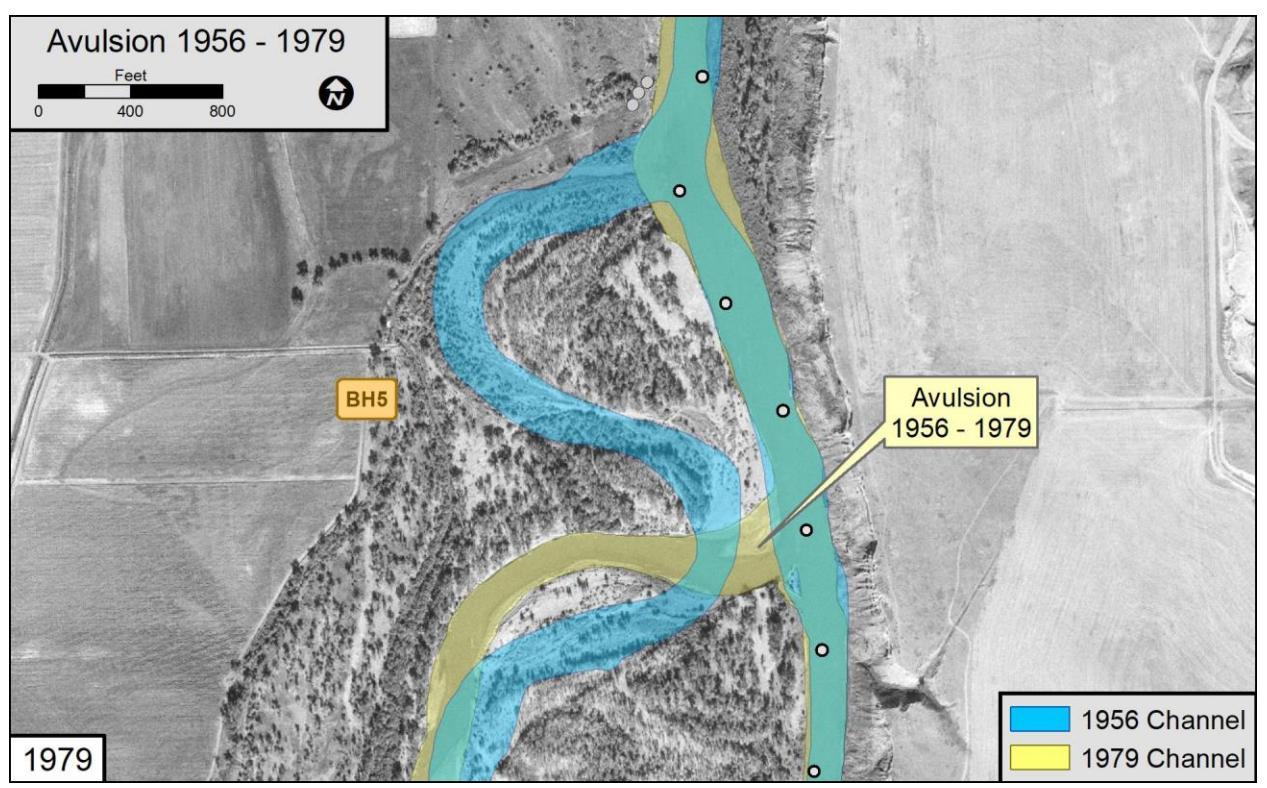
Figure 61. Avulsion at RM 43.5 that abandoned almost 3,000 feet of channel.

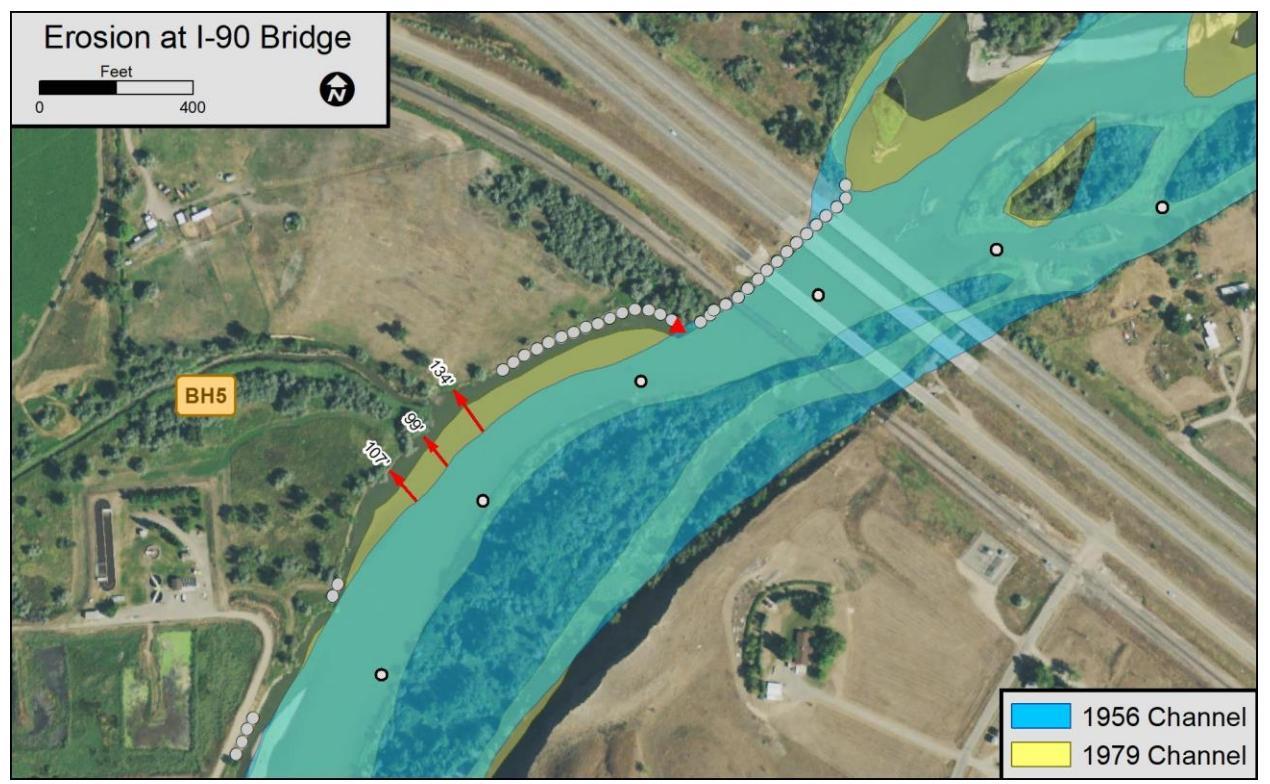
Figure 62. Left bank erosion above interstate bridge that appears to be flanking bank armor.

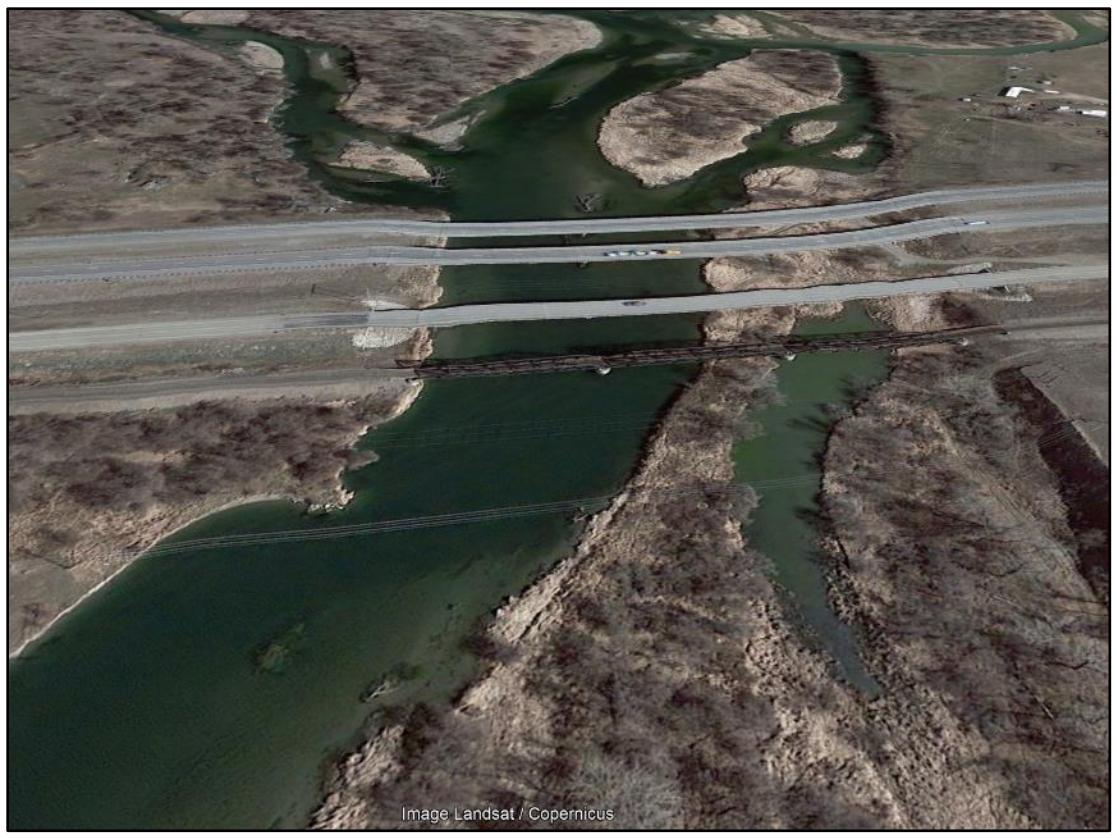
Figure 63. Google Earth image showing flanking of left bank armor above Interstate Bridge.

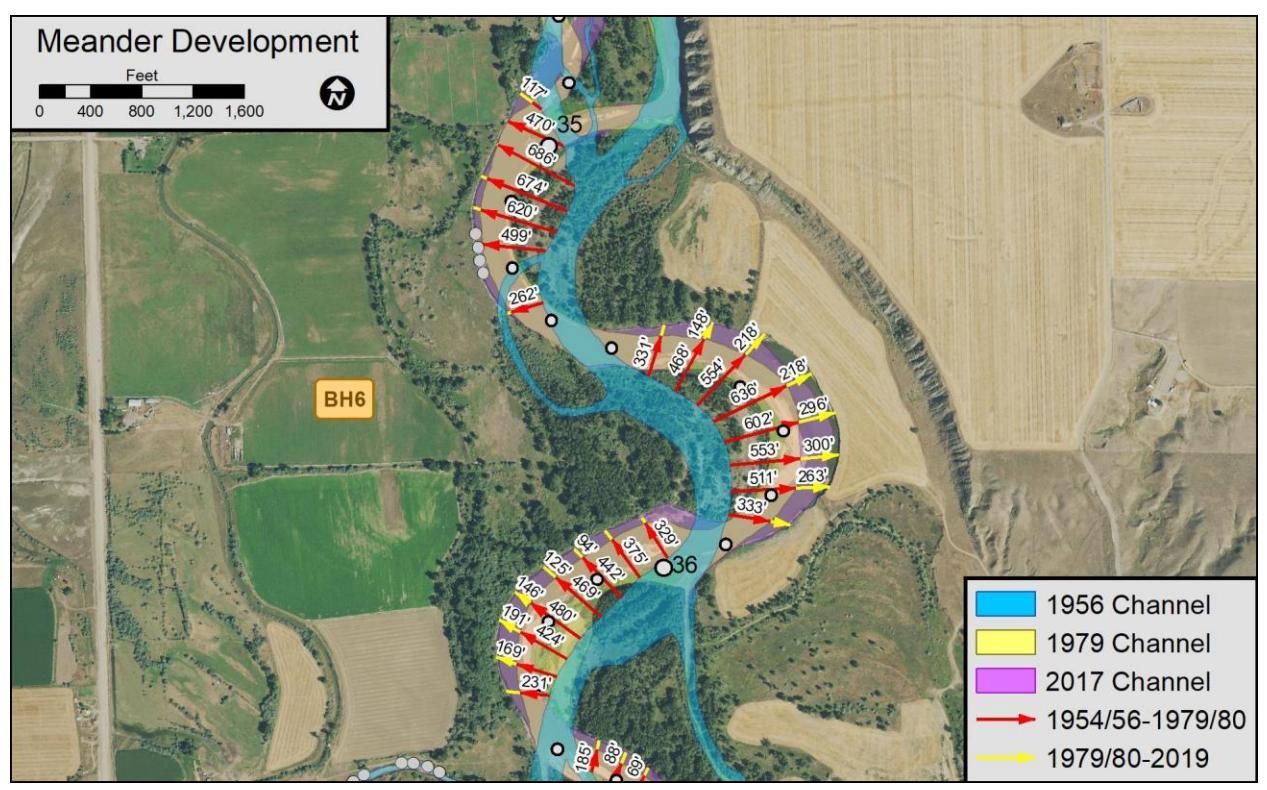
Figure 65. Large meander migration across floodplain causing field erosion, RM 35.7.

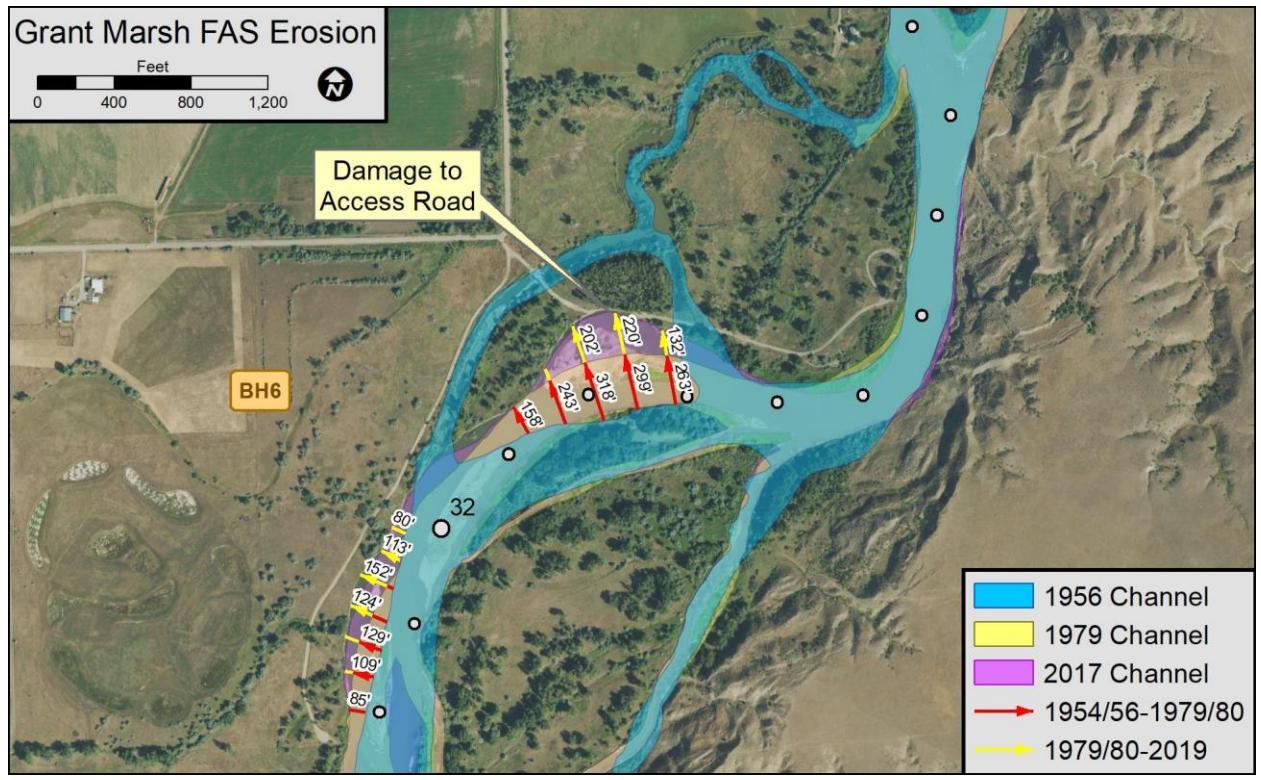
Figure 66. Northward channel migration into Grand Marsh FAS.

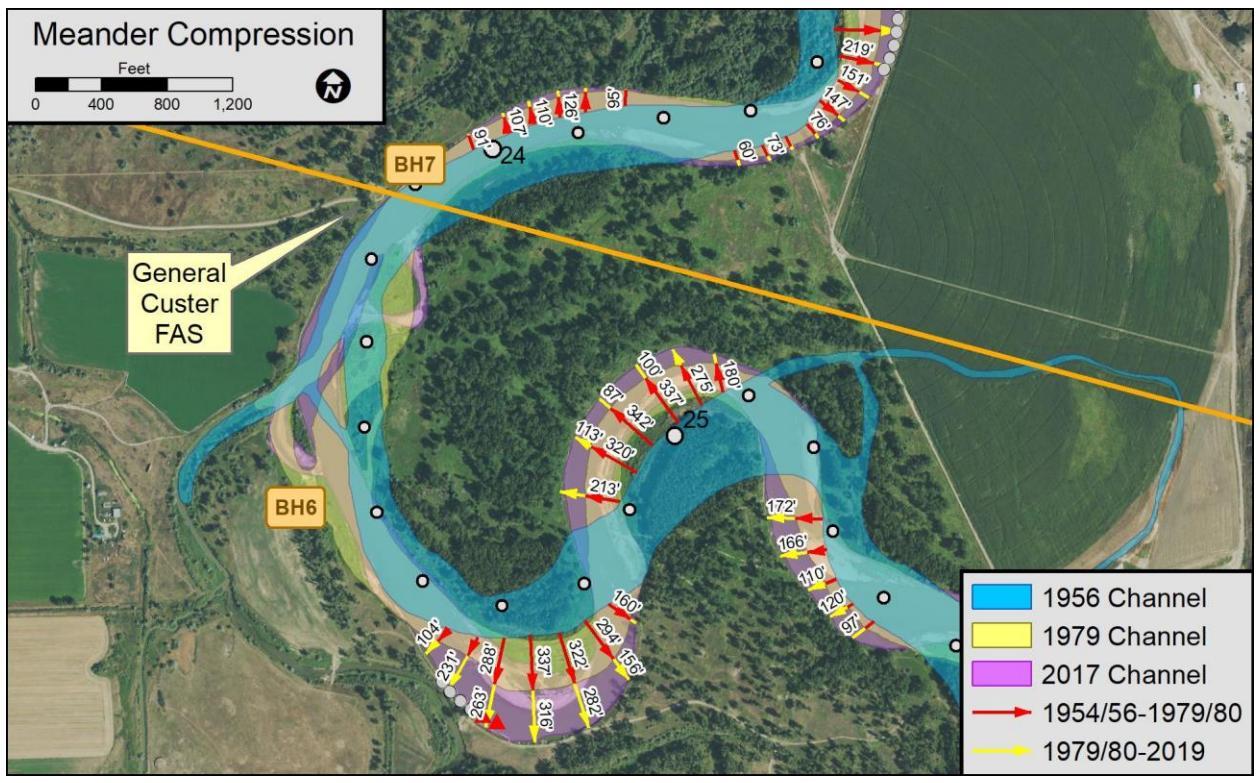
Figure 67. Meander compression at General Custer FAS; an avulsion across the meander core would abandon the site.

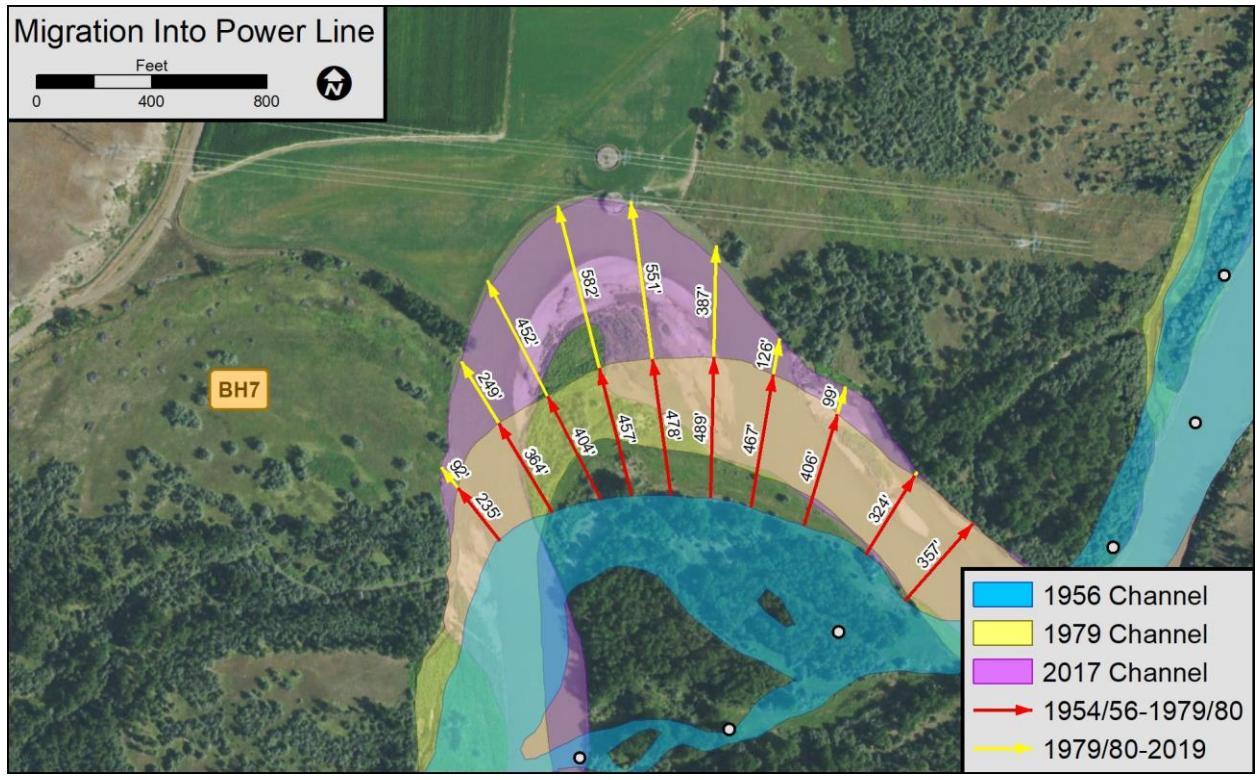
Figure 70. Migration into power line tower at RM 18.7.

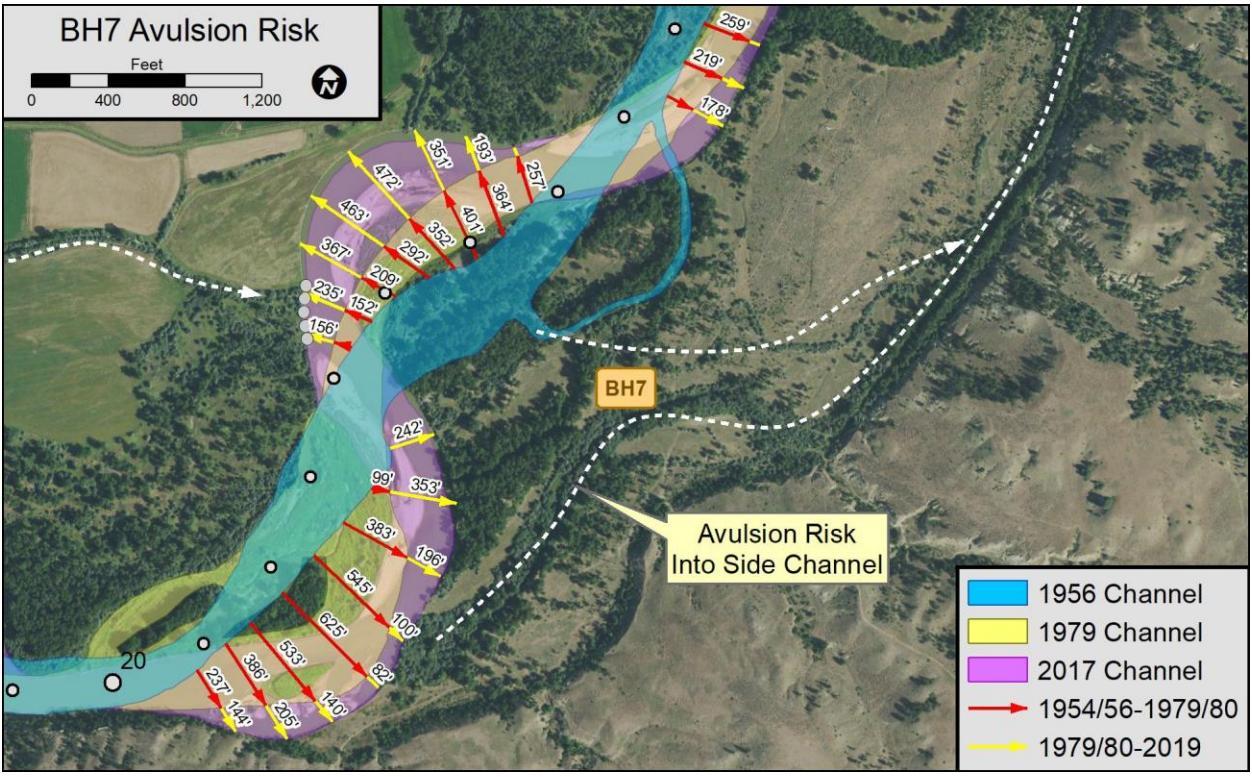
Figure 71. Migration into a long side channel at RM 20.8 creating a heightened risk of avulsion.
