SPATIAL IMAGERY
CONSOLIDATION AND
CHANNEL FEATURE DELINEATION

Tony Thatcher
DTM Consulting, Inc.
tony@dtmgis.com

September 15, 2019

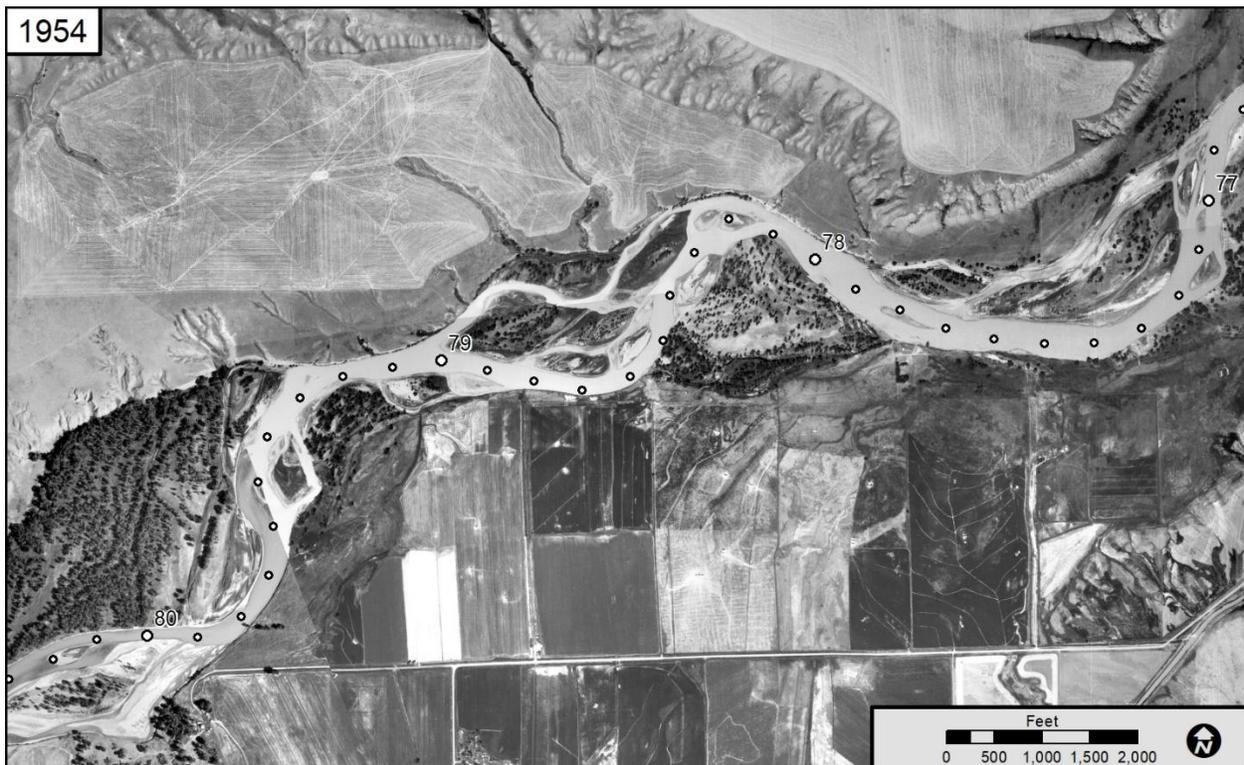
Figure 2. 1954 imagery example.

- 1954/1956 –
 - 1954 – Yellowtail Dam to Mallard's Fishing Access Site (FAS) – (Figure 2) This data set was provided from the COE. It was generated from scanned and likely georeferenced imagery. All imagery is black and white. The spatial accuracy is generally good along the river corridor, though it does lack some accuracy around the edges of the mosaic. The exact dates for the imagery are not available but flows during that summer of 1954 ranged from 2,000 to 4,000 cfs.

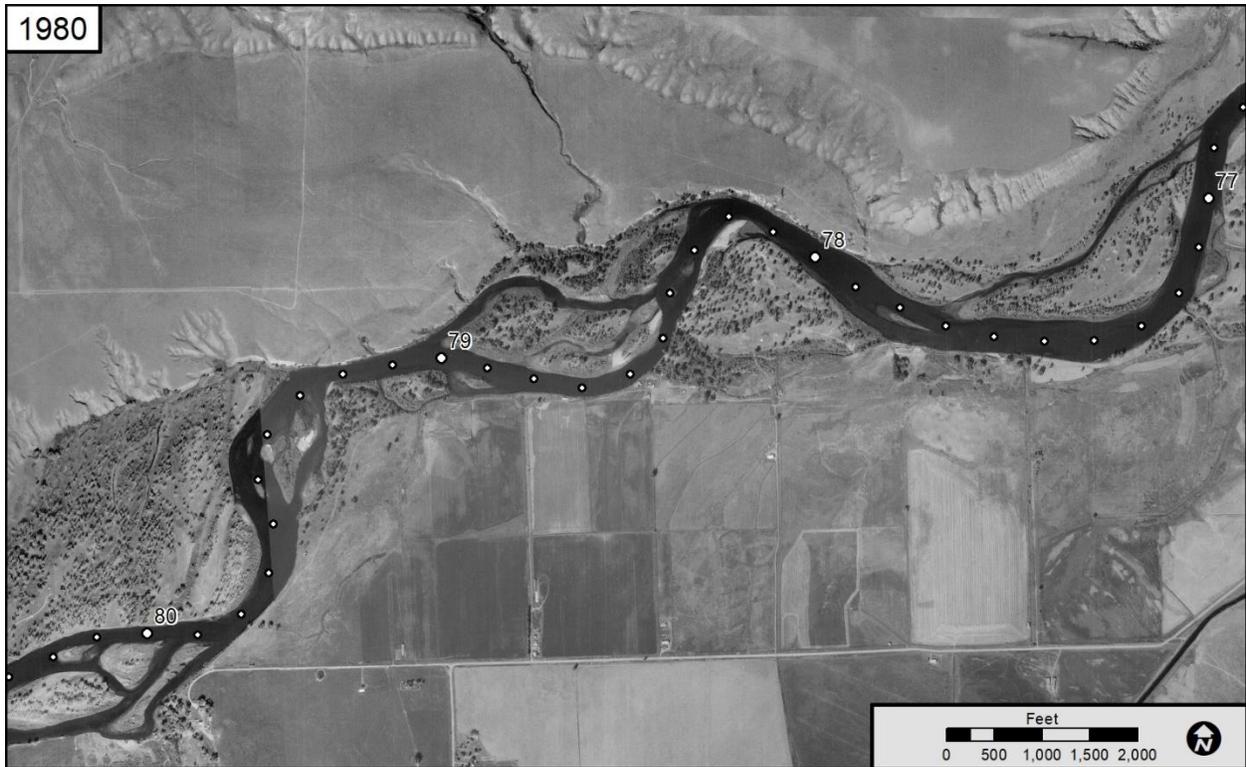
Figure 3. 1980 imagery example.

- 1979/1980 –
 - 1980 – Yellowtail Dam to Mallard's FAS – (Figure 3) This data set was provided from the COE. It was generated from scanned and likely georeferenced imagery. All imagery is black and white. The spatial accuracy is generally good along the river corridor, though it does lack some accuracy around the edges of the mosaic and deviates significantly upstream of the Afterbay Dam. The exact dates for the imagery are not available but flows during that time period ranged from 3,000 to 4,000 cfs.

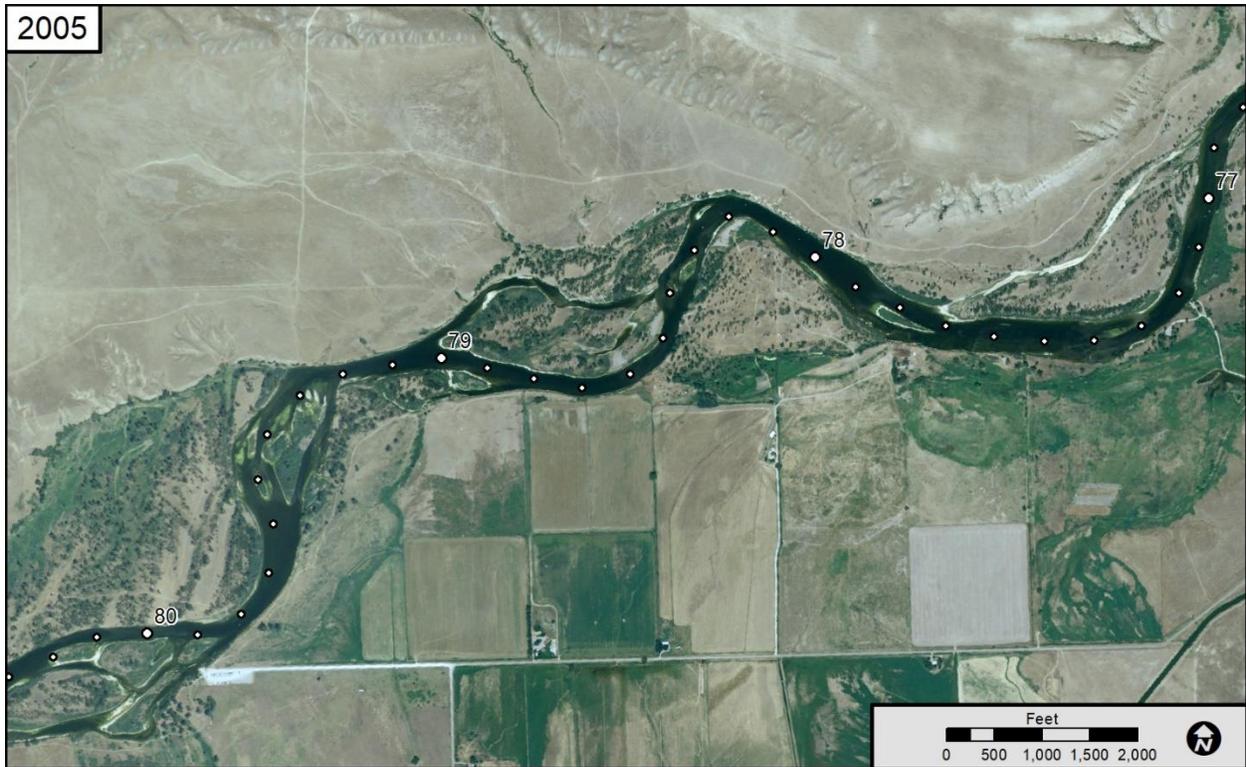
Figure 5. 2005 NAIP imagery example.

- 2005 NAIP – (Figure 5) The 2005 National Agricultural Imagery Program (NAIP) imagery Compressed County Mosaic (CCM) was downloaded from the State of Montana Library. The imagery is color, with a near infrared band available. Spatial accuracy is excellent. The imagery is almost entirely from July 13, 2005 (4,410 cfs).

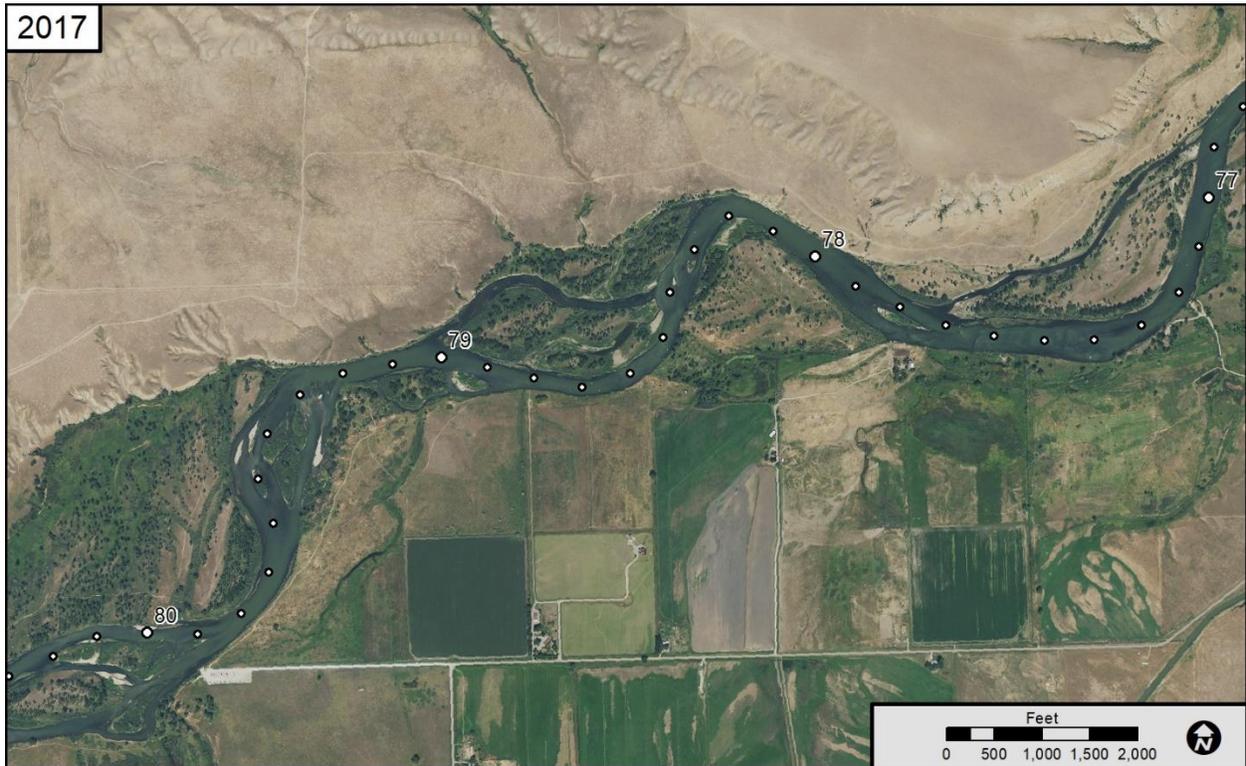
Figure 6. 2017 NAIP imagery example.

- 2017 NAIP – (Figure 6) The 2017 National Agricultural Imagery Program imagery Compressed County Mosaic (CCM) was downloaded from the State of Montana Library. The imagery is color, with a near infrared band available. Spatial accuracy is excellent. The imagery is from August 10 (3,990 cfs) and August 18, 2017 (3,140 cfs).

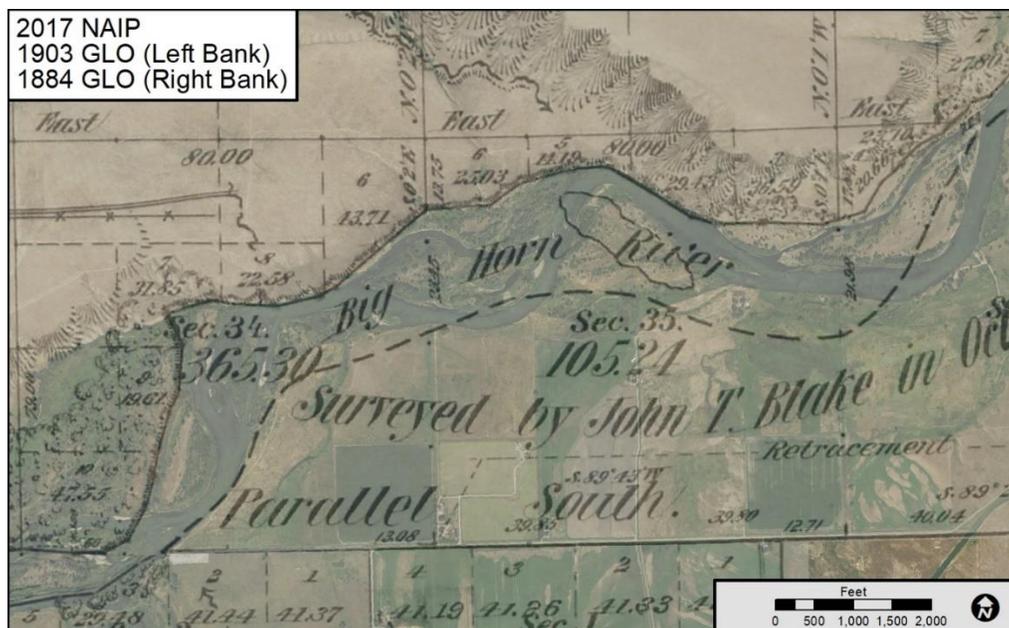
Figure 7. Example General Land Office Survey (GLO) map overlain on color imagery.

General Land Office (GLO) maps from the 1880s through 1920s often form the earliest available mapping along river corridors in the west. They are available as scanned images by township from the Bureau of Land Management (BLM). The key GLO maps from the current Yellowtail Dam location to the Yellowstone River were georeferenced to PLSS Section corners. In many cases, one bank of the river will have mapping from one survey effort, while the opposite bank is from another survey performed up to 40 years later. Additionally, the surveying for the GLO maps was conducted only along the Section lines. Thus, the location of river banklines shown on the GLO maps (as well as other features on the GLO maps) are only accurate for the date of the survey and only where it crosses a section line. The rest of the river banklines are interpreted between the section line crossing points and represent the approximate bankline shape and location noted by the surveyor. It is important to keep this in mind when viewing the GLO maps.

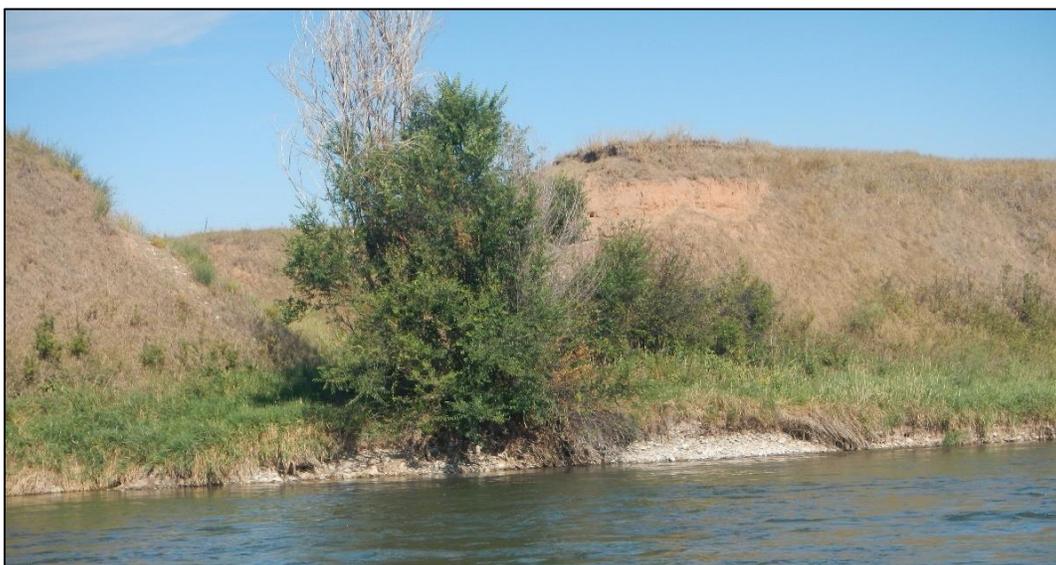
Figure 17. View downstream of alluvial terrace known as “Red Cliffs”; note coarse gravel toe.

Reach BH1 supports broad open meanders with a sparse woody riparian corridor. The high left bank at RM 81.5 known as the “Red Cliffs” consists of a high terrace that is mainly fine-grained, but also contains substantial amounts of gravel that is being actively eroded into the river, contributing to mobile substrate that will support spawning (Figure 17).

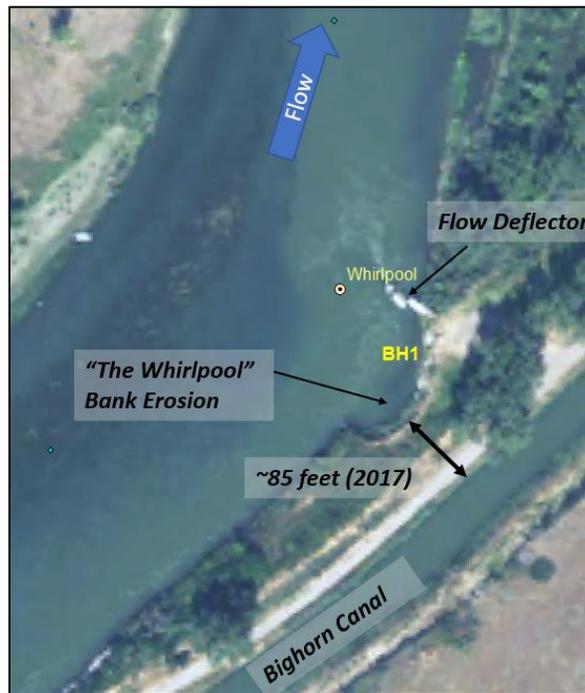
Figure 20. 2017 air photo showing scour upstream of flow deflector; back eddy has eroded the bank towards Bighorn Canal.

The Bighorn Canal closely follows the River on the right bank for about a mile below Afterbay Dam. There are several large concrete flow deflectors on the streambank in this area, and there has been some substantial scour upstream of one deflector, an area known as “The Whirlpool” (Figure 19). This flow deflector was built sometime prior to 1970, and the bank is currently about 85 feet from the canal margin (Figure 20).

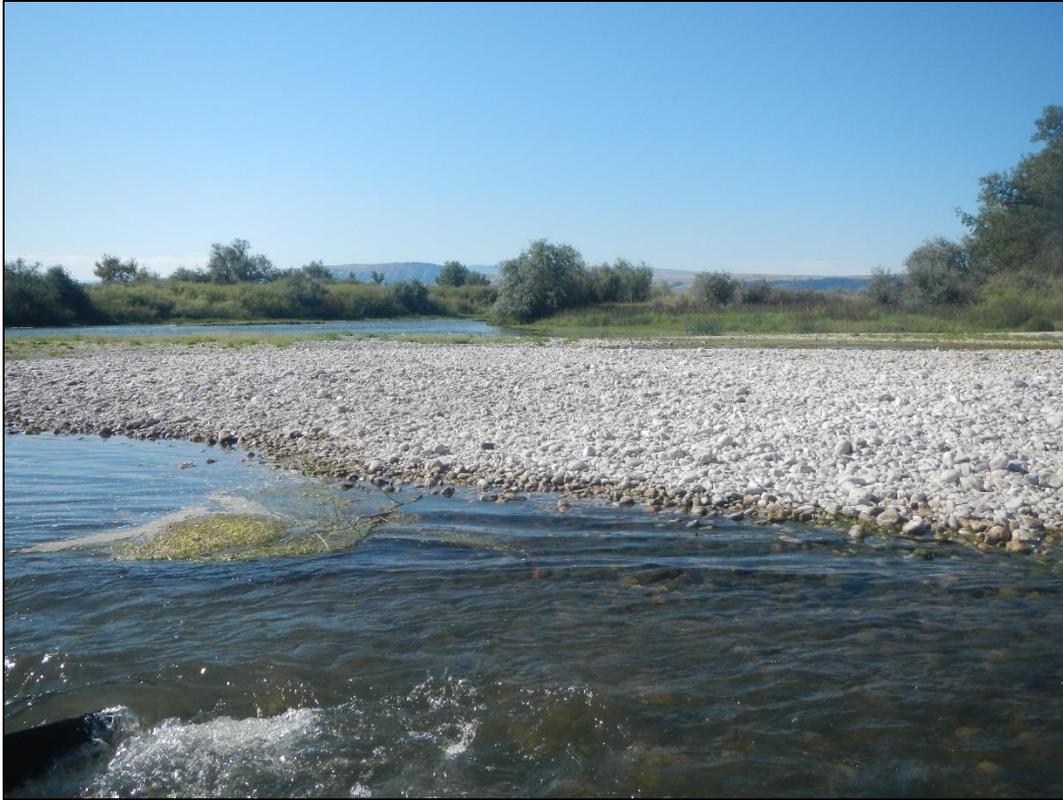
Figure 22. Recent gravel bar formation on island complex just upstream of 3 Mile Fishing Access.

Channel migration has been minimal in this section of river since at least 1954. The only area showing notable change is the island complex on the lower end of the reach (Bureau of Reclamation "Channel Complex #6 just upstream of the 3-mile boat ramp), where recent changes have included island dissection, trimming, and new gravel bar formation. Figure 21 shows how the islands have changed since 1939, with some stabilization via vegetation and loss of open bar area. With recent high flows, however, there has been substantial bedload movement in the reach and some new open gravel bars have formed (Figure 22).

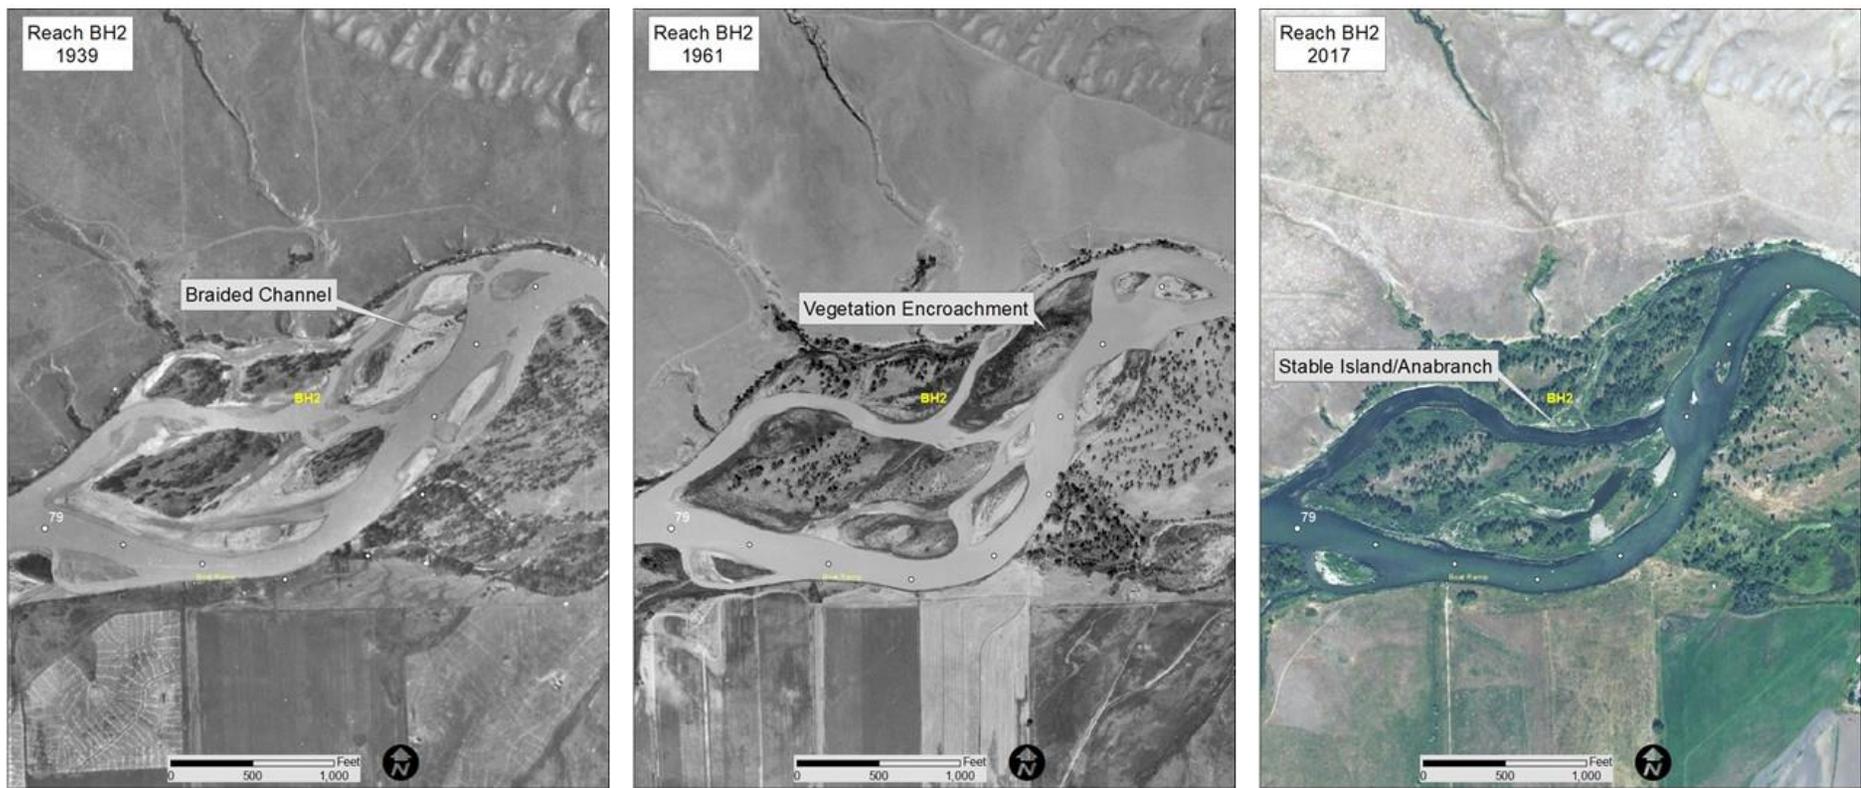
Figure 35. Comparison of section of BH2 at Duck Blind Channel showing channel simplification since 1939—flow direction is left to right.

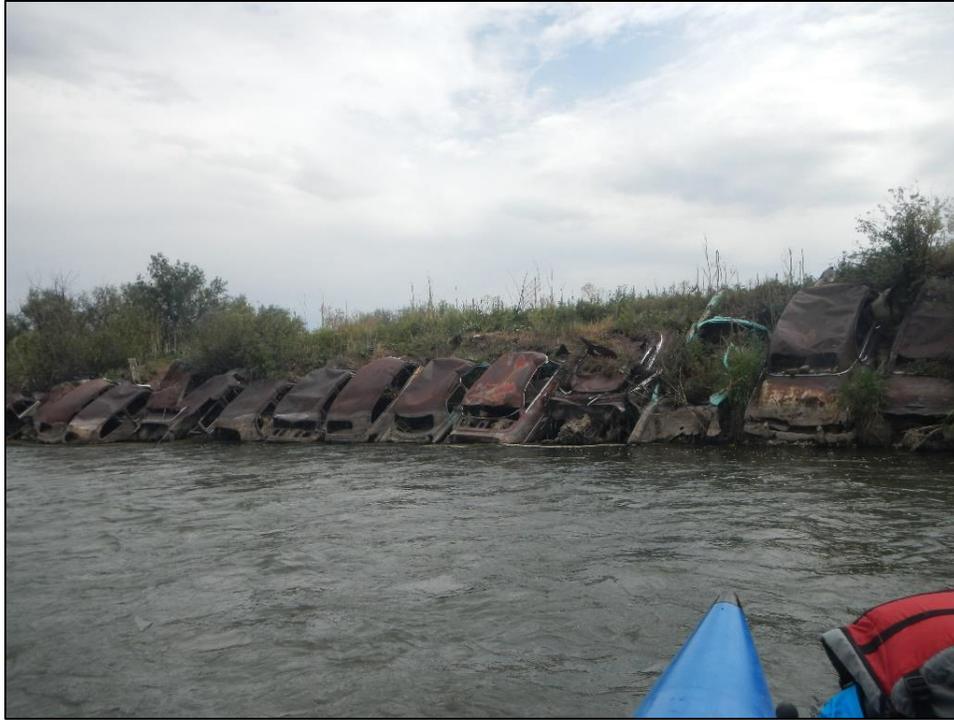
Figure 36. “Detroit Riprap”, also known as the “Drive-In” RM 78.5R.

Bank erosion has been a concern in this reach for decades (Figure 36), however it is important to acknowledge that the erosion will be necessary to mitigate eventual gravel depletions below the dam. Guides noted that more bedrock has become exposed in the streambed in recent years, indicating that bedrock sills will help prevent downcutting, but also that bedload has been exported from certain areas. A Google Earth image of Cabin Run shows a large sediment wave migrating down river, exemplifying patterns of sediment movement during high flows (Figure 37).

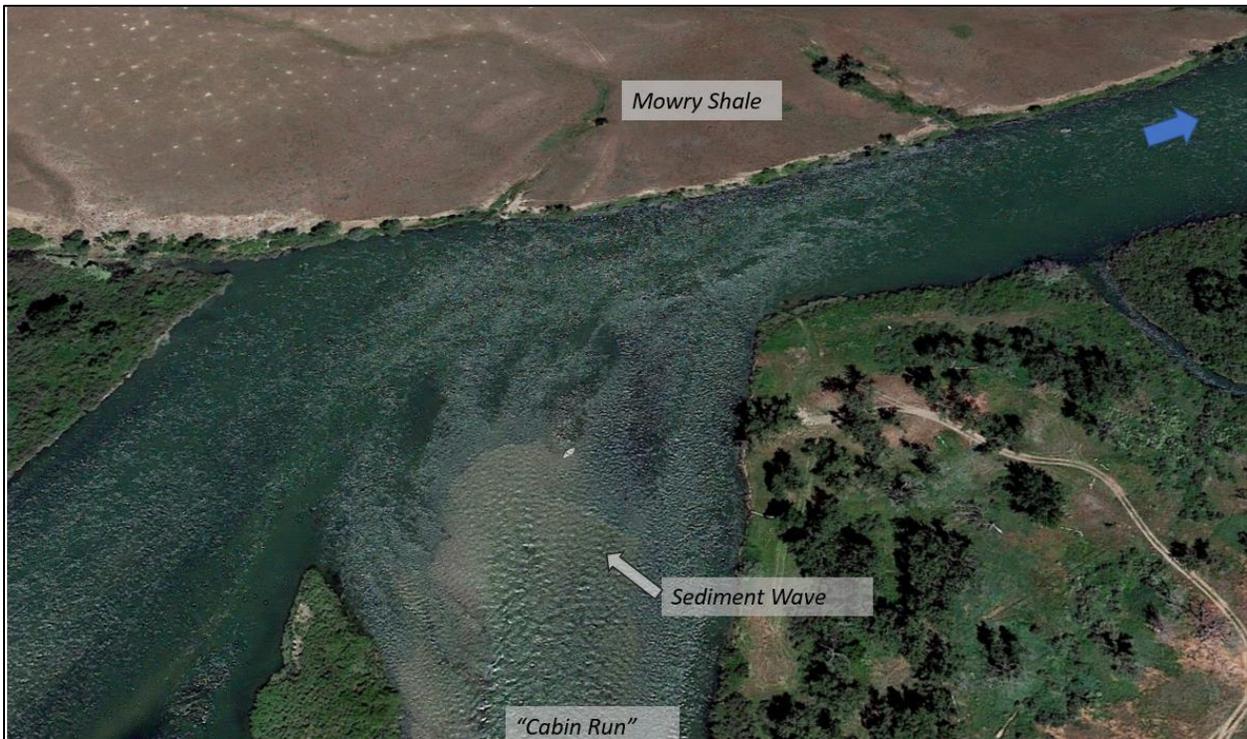
Figure 37. Google Earth image showing river hitting erosion resistant Mowry Shale unit; note sediment wave pattern on lower end of Cabin Run; the light spot at end of wave is a drift boat.

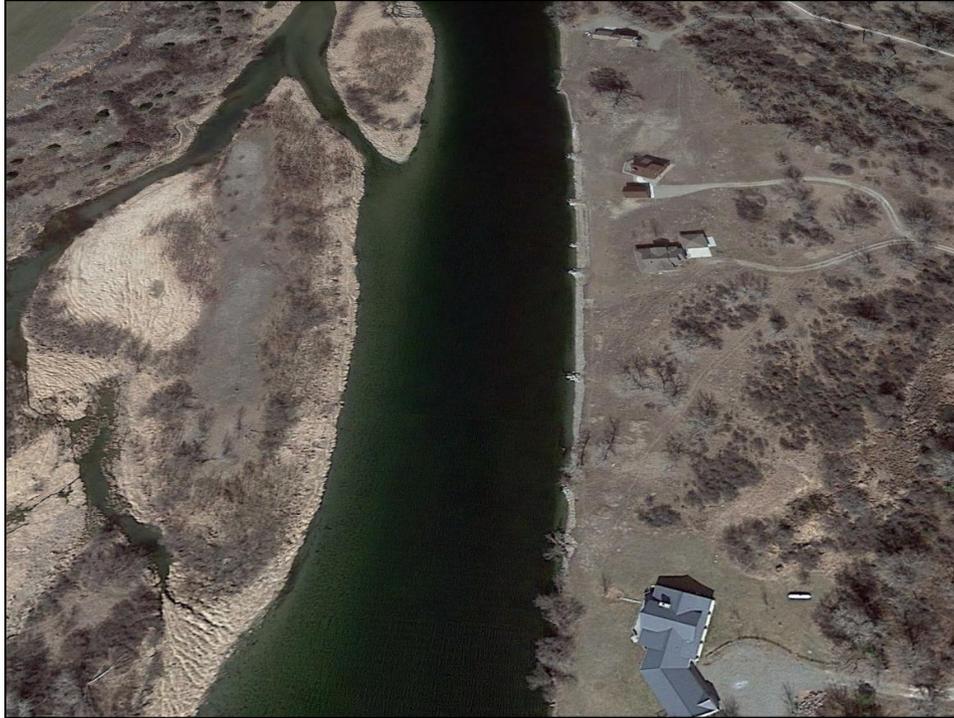
Figure 39. View downstream of barbs protecting homes just below St. Xavier Bridge.

Although rates of channel movement have been lower since the completion of Yellowtail Dam, there is sufficient sinuosity to impart some channel movement. Right below the St Xavier Bridge, for example, the construction of a series of homes exceedingly close to the river (one within about 50 feet) has resulted in the construction of a series of barbs along that bankline (Figure 39).

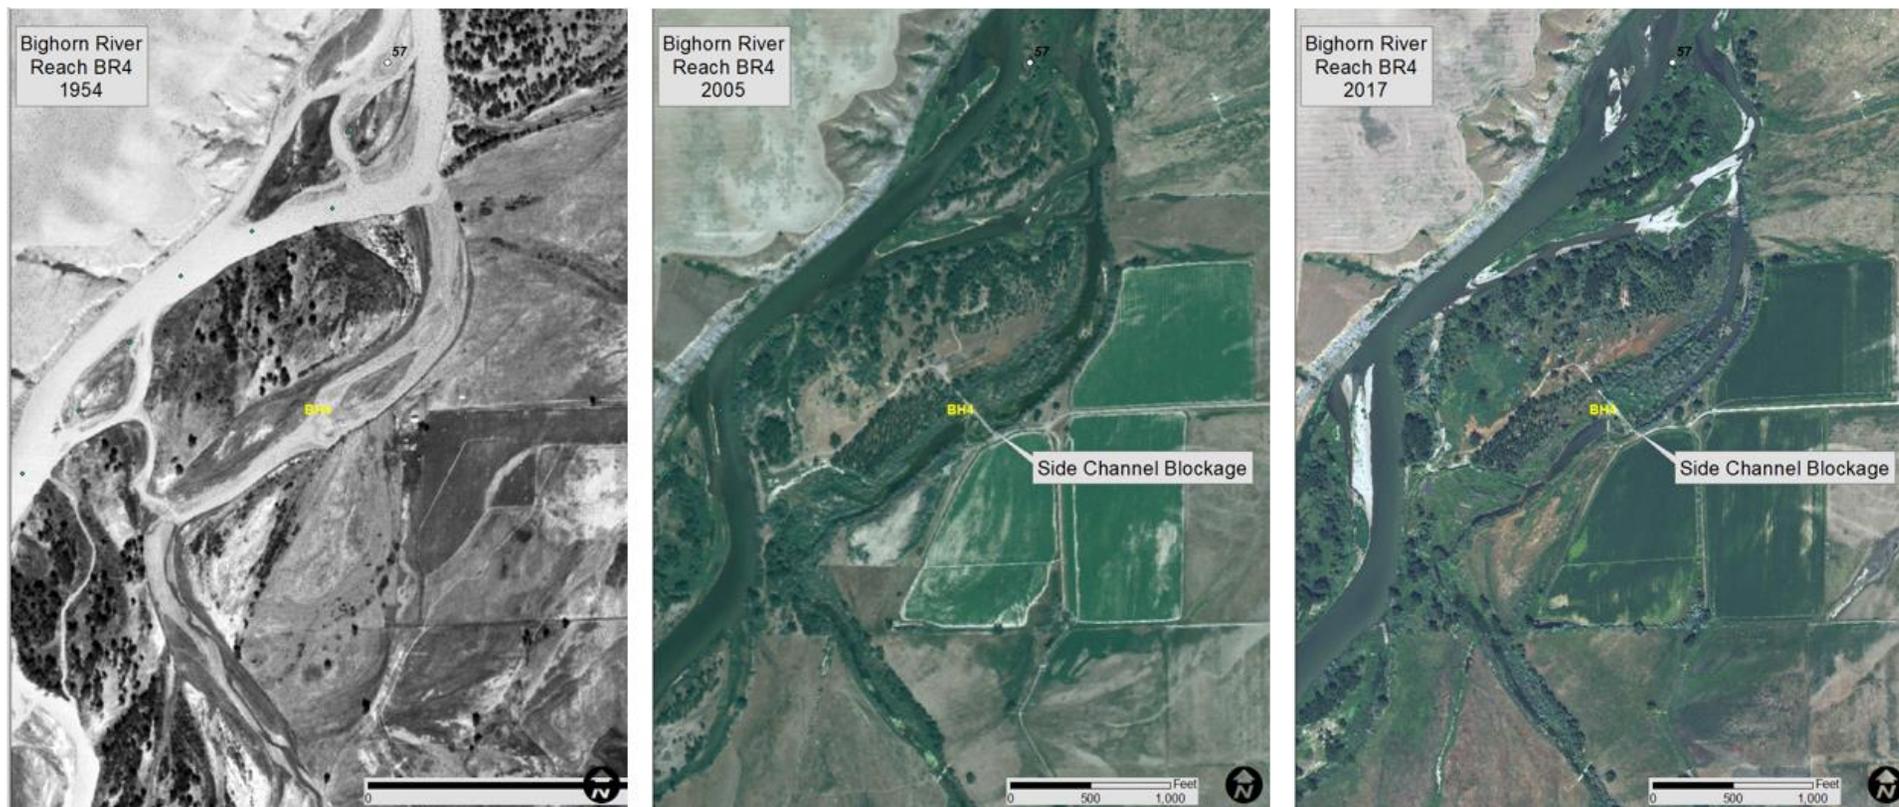
Figure 42. Side channel blockage at RM 57.3 sometime between 1954 (left) and 2005 (center)—flow direction is to northeast.

This reach has several complex island segments, which formed primarily with vegetation expansion since 1950. One example of a side channel blockage is evident in the middle portion of the reach, where a road has blocked a channel (Figure 42). This channel has been slated for potential reactivation.
