BIGHORN RIVER SIDE CHANNEL RESTORATION PROJECT

ANNUAL MONITORING REPORT - 2023

February 2024

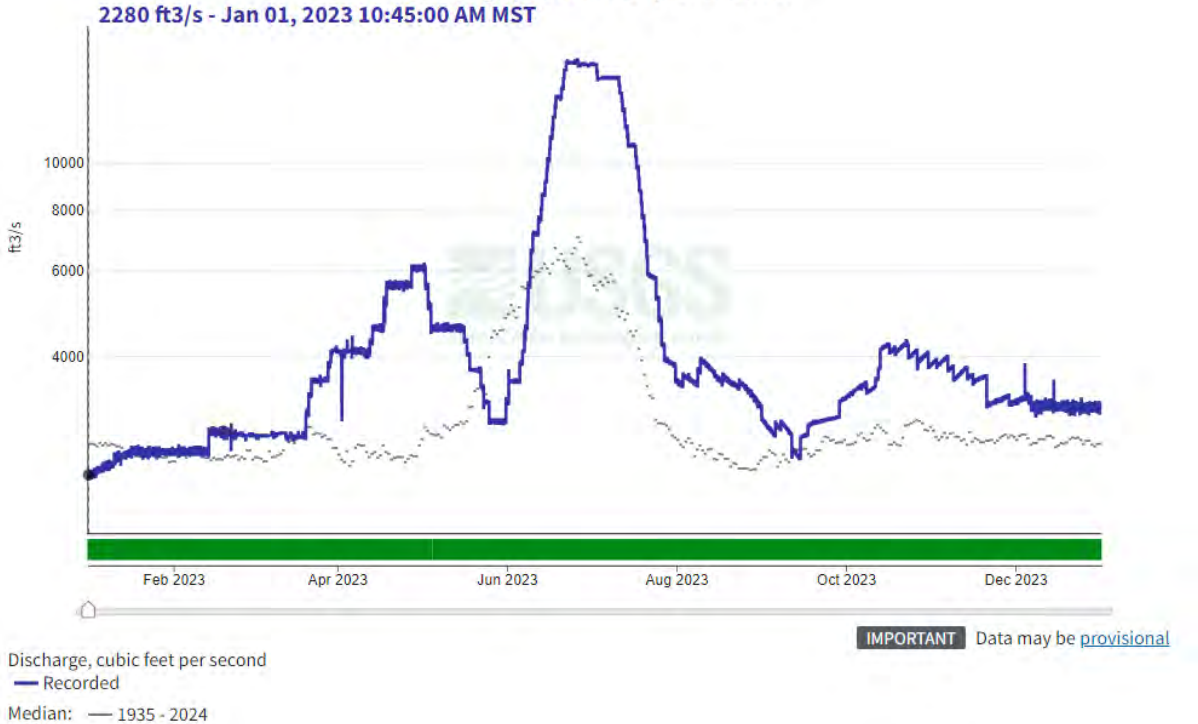
Figure 2. 2023 hydrograph and mean daily flows between 1935 and 2024 for Bighorn River below Afterbay Dam.

Above average precipitation in southern Montana and northern Wyoming in June of 2023 prompted the Bureau of Reclamation to release excess water through Yellowtail Dam. Discharge records provided by the USGS indicate a peak flow of 16,200 cfs was released on June 25th, as compared to an average annual peak flow of around 7,200 cfs over the period of record (Figure 2). The release of well above-average flows resulted in widespread flooding, erosion, sediment deposition, and both habitat creation and destruction along the lower Bighorn River. The prolonged flood in 2023 provided an excellent opportunity to assess whether the approach of improving connectivity to side channels by excavating deposits and reconfiguring entrance angles is sustainable following very high flow events.

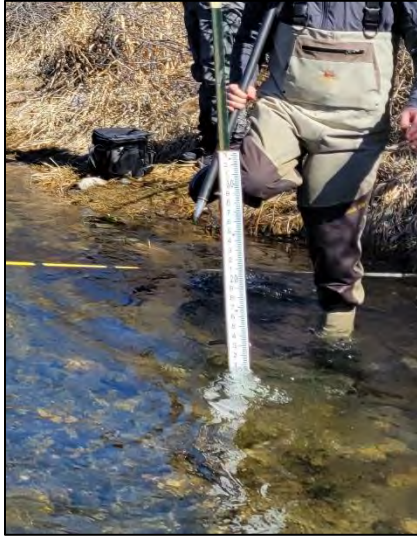
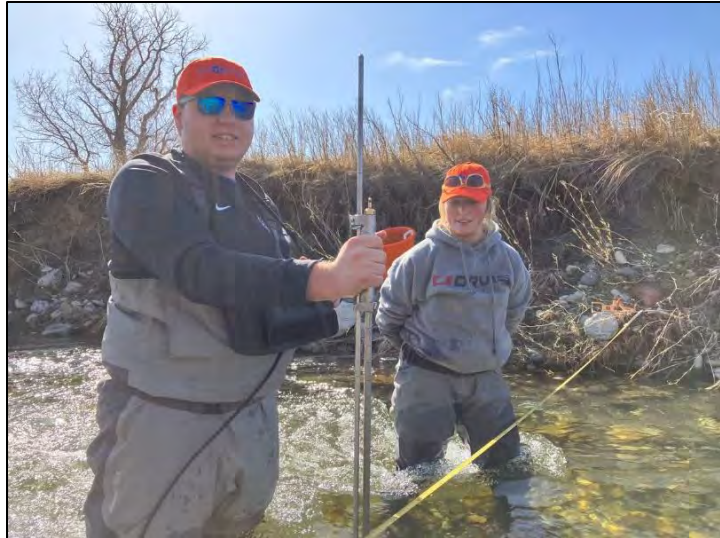
Staff gages were installed in both side channels in April 2023 (left photo below). Side channel discharges were monitored using a Marsh-McBirney flow meter and top-setting rod (right photo below). Discharges were measured six times in 2023 over a range of flows to create an initial stage-discharge relationship and rating curve for each side channel.

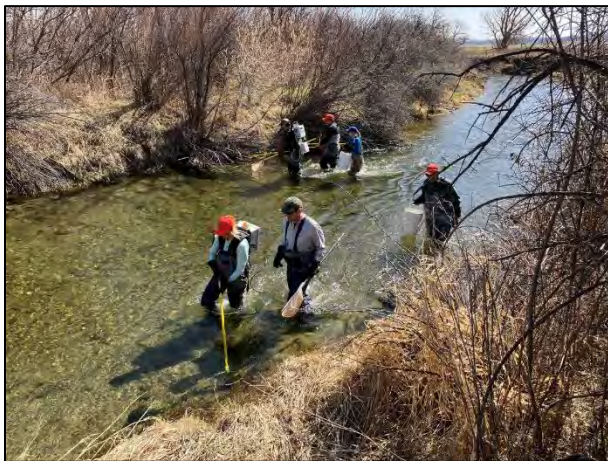
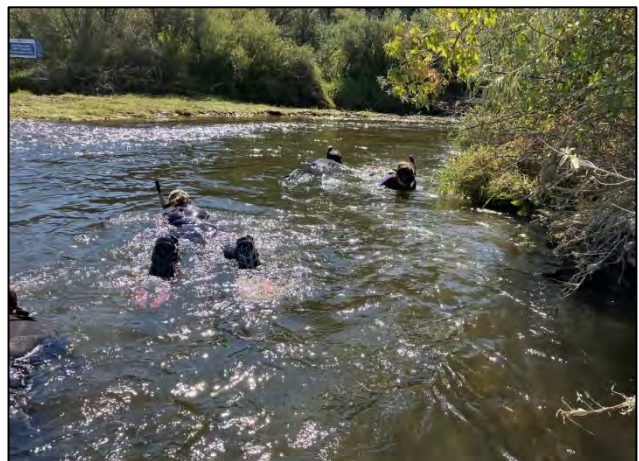
The use of side channel habitats by fish was initially assessed using backpack electroshocking units (left photo below), with the intent of sampling presence/absence and abundance of fish. The first fish sampling event occurred in April, which indicated the use of backpack electroshocking equipment was not effective in sampling due to the size of the side channels and high water velocities in some areas. Subsequent fish sampling events involved 2- and 3-person snorkeling crews cataloging species and lengths of individual fish observed (right photo below).

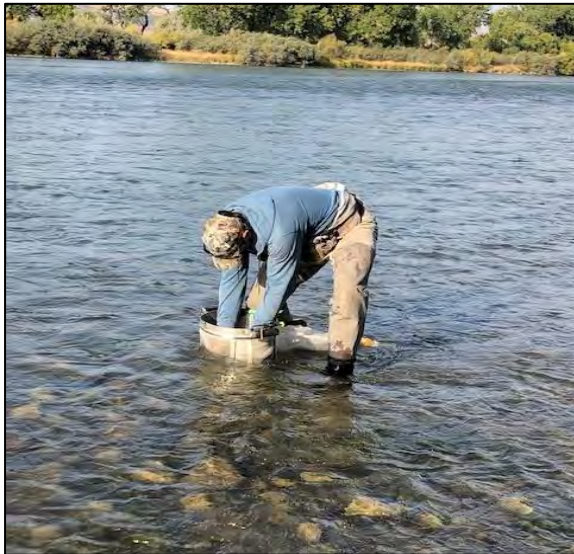
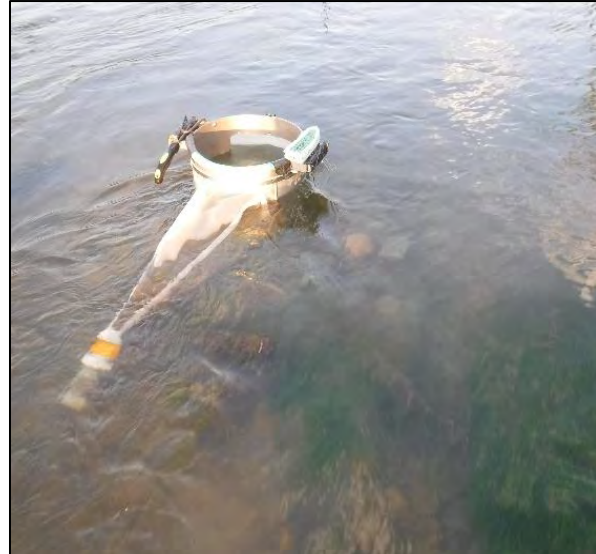
Three replicate Hess (33 cm diameter, 500-micron mesh) samples were collected within a designated riffle in each side channel to quantitatively sample macroinvertebrates (left photo below). Each Hess sample constituted a benthic area of 0.1 m², so a multiplier of 10 was applied to the numbers of total invertebrates in each sample to achieve a per meter squared estimate. At each sampling point, the Hess sampler was pushed into the stream bottom to form an effective seal and all cobbles (>64 mm) within the sampler were scrubbed clean of organisms and removed; then the entire area within the sampler frame was raked for one minute until all organic matter and macroinvertebrates were washed into the collection net of the Hess sampler (right photo below). Samples were collected in mid-April and mid-September.

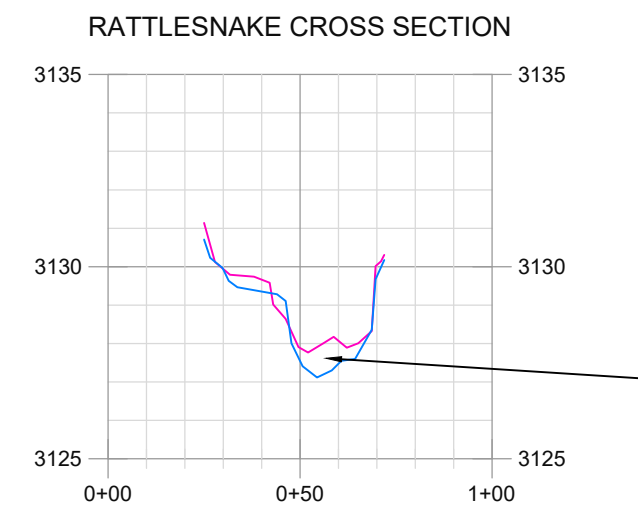
RATTLESNAKE SIDE CHANNEL MONITORING

Results of the Rattlesnake side channel longitudinal profile and cross section survey are illustrated on Sheet 1 in Appendix A. Sheet 2 provides an illustration of elevation changes between the spring and fall 2023 surveys along the upper 200 feet of the channel. These results indicate the following:

- The elevation of the channel bed at the monitoring cross section rose by ~0.5 to 0.7 feet, indicating gravel deposited in this particular location during the 2023 flood.

- The longitudinal profile indicates gravel has deposited and the thalweg (deepest part) of the channel has become shallower between Stations 0+00 and 0+40 and between Stations 0+60 and 1+20.

- Gravel has not deposited between Station 0+40 and 0+60, which was the original crest of the restored side channel entrance.
- The gravel deposit between Stations 0+60 and 1+00 has adjusted the elevation at the entrance of the channel to approximately 0.1' higher than the design grade. Although this deposit has slightly elevated the entrance elevation, the side channel will remain connected to the mainstem river at lower flows than prior to the reconnection project.

- The longitudinal profile indicates the controlling elevations of the bed slope closely match the proposed grade along the length of Rattlesnake side channel.

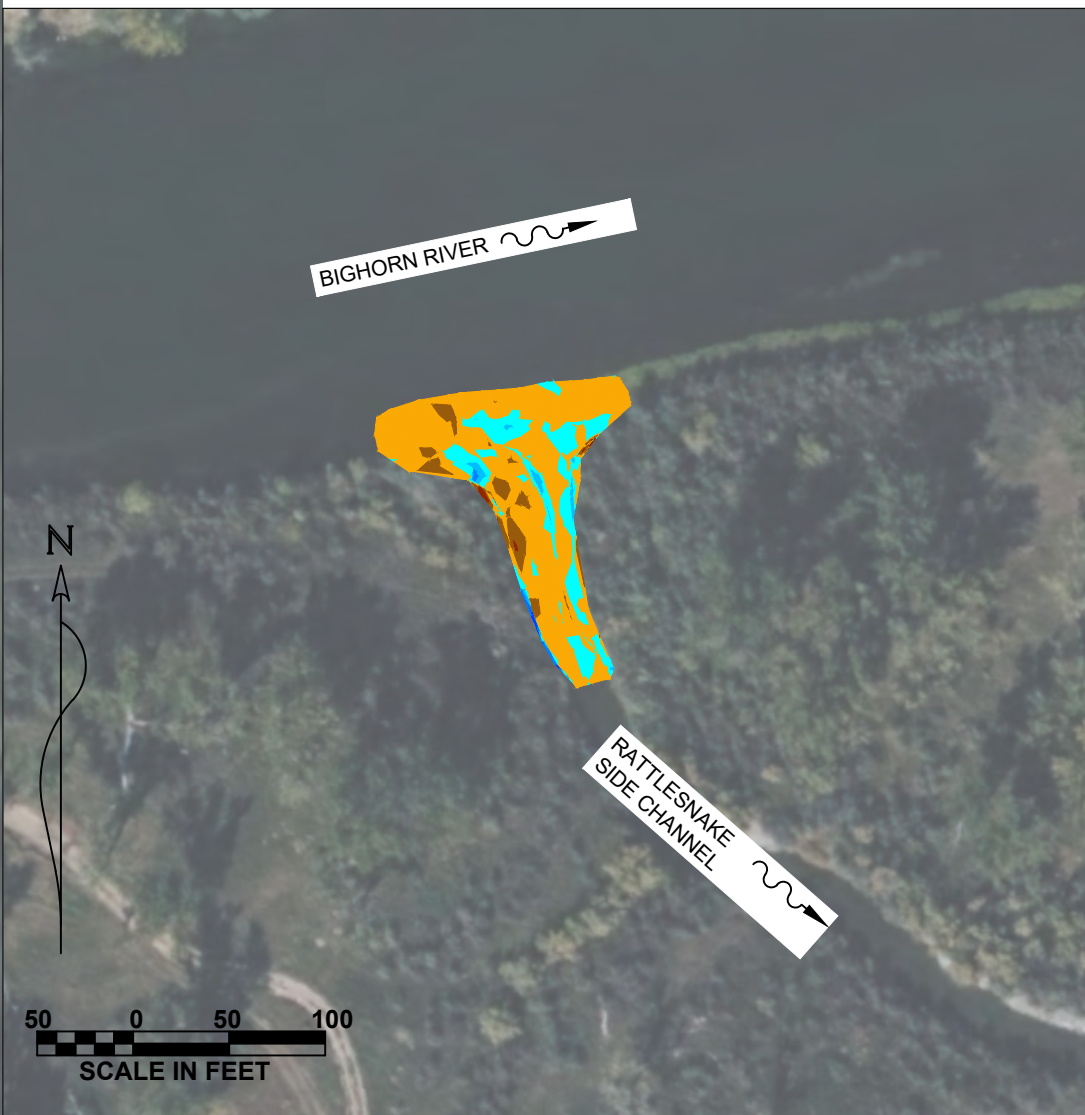
RATTLESNAKE
2022/2023
VOLUME
COMPARISON

- A comparison of pre- and post- 2023 flood elevations at the entrance indicates up to 0.7 feet of gravel has deposited on the inside of the entrance bend and has scoured up to 0.5 feet on the outside of the bend. This pattern of scour and deposition is typical for a meander bend.

1. VOLUME COMPARISON IS BETWEEN SPRING 2023 SURVEY AND FALL 2023 SURVEY.
2. A FILL VALUE IS MATERIAL GAIN BETWEEN SPRING 2023 AND FALL 2023.
3. A CUT VALUE IS MATERIAL LOSS BETWEEN SPRING 2023 AND FALL 2023.
4. TOTAL FILL VOLUME = 62 CUBIC YARDS
5. TOTAL CUT VOLUME = 20 CUBIC YARDS
6. NET CUT/FILL = 42 CUBIC YARDS OF FILL

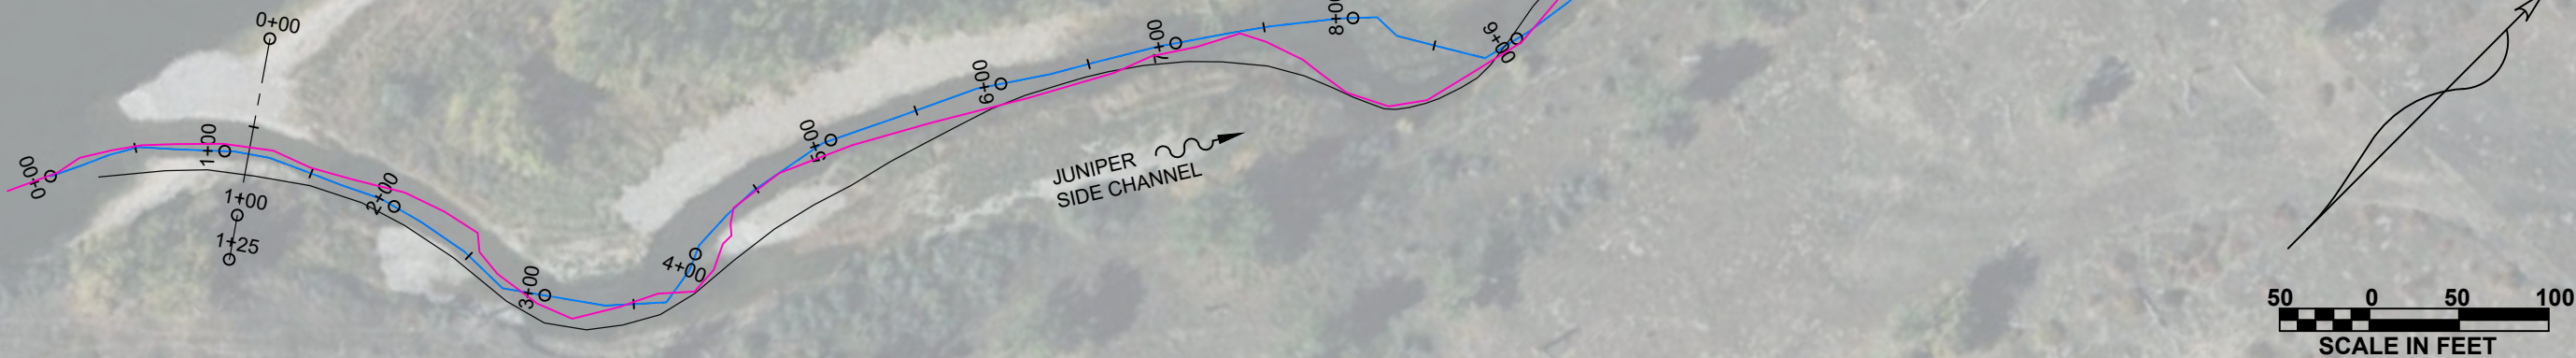
JUNIPER SIDE CHANNEL MONITORING

Results of the Juniper side channel longitudinal profile and cross section survey are illustrated on Sheet 3 in Appendix A. Sheet 4 provides an illustration of elevation changes between the spring and fall 2023 surveys along the upper 250 feet of the channel. These results indicate the following:

- The elevation of the channel bed through the monitoring cross section remained consistent following the 2023 flood.
- The longitudinal profile shows little change in elevation at the entrance, indicating efficient sediment transport through the upstream end of the channel.

- The channel has not aggraded above the design grade, indicating it should remain connected with the mainstem river during target flows.
- Deeper pool habitat has developed on the outside bend of the side channel entrance between Stations 1+50 and 2+50.

- The thalweg may have shifted eastward between Station 7+50 and 9+00; however, the longitudinal profile indicates the crest elevation of the controlling riffle has remained consistent in this area.

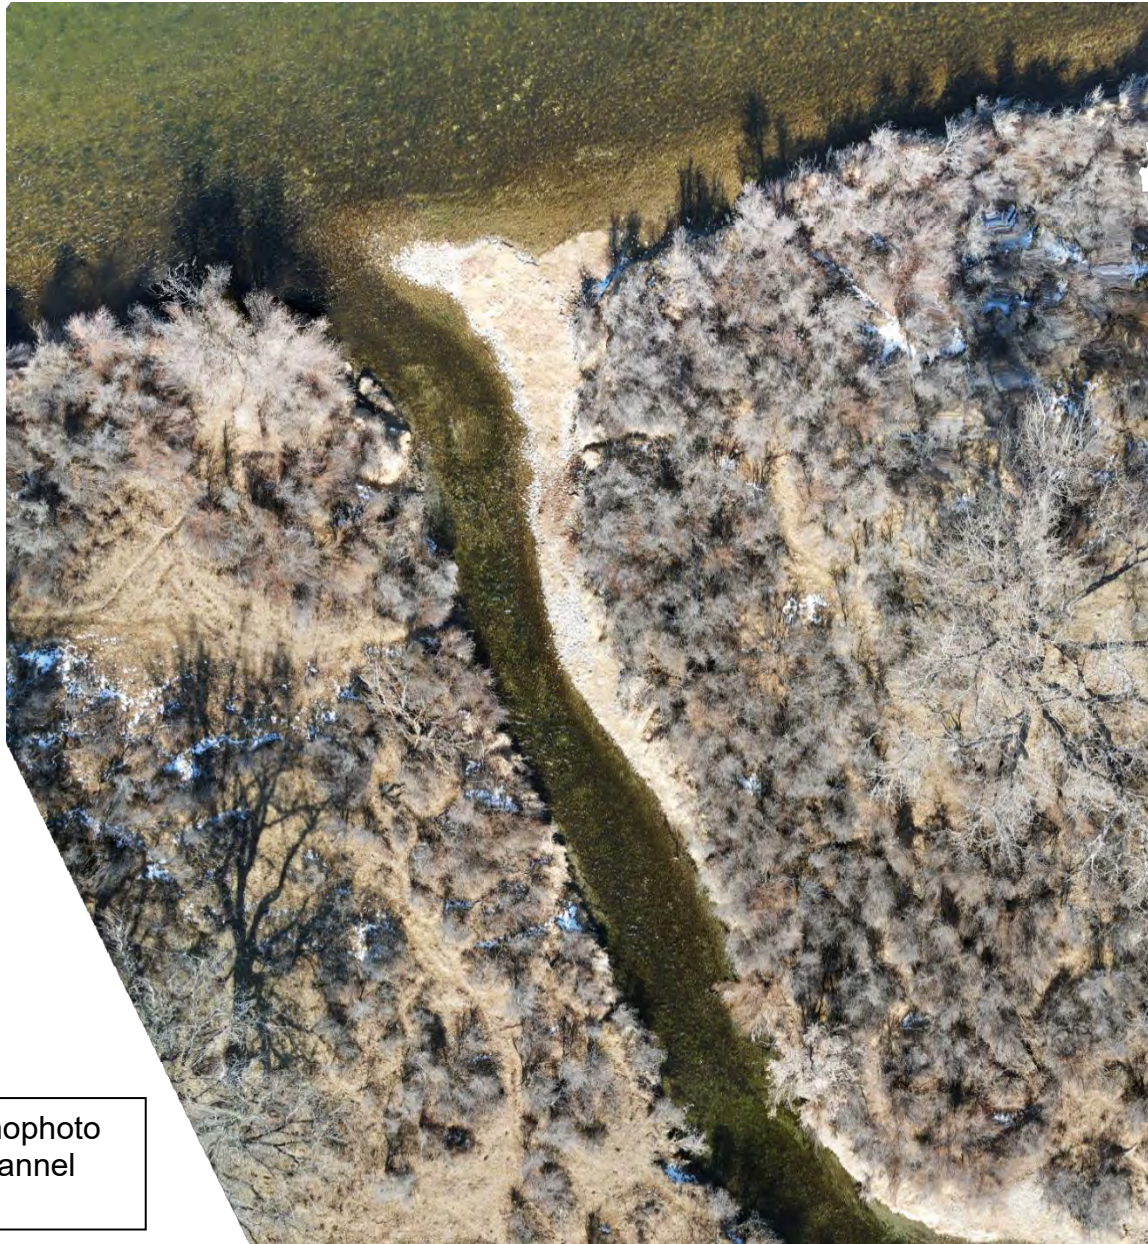
February 22, 2024 Orthophoto
of Rattlesnake Side Channel
Entrance

Results of the drone-based orthophotography are provided in Appendix C and indicate a wetted area for the Rattlesnake side channel of 26,340 square feet (0.60 acres) on April 7th, 2023, during a mainstem river discharge of 4,070 cfs. This area increased to 33,489 square feet (0.77 acres) on June 17th, 2023, during a mainstem river discharge of 11,000 cfs. A third orthophoto taken on February 23, 2024 offers a view of gravel deposits near the entrance of the side channel following the 2023 flood.
