2020 REPORT 4

BIGHORN RIVER CHANNEL MIGRATION ZONE MAPPING

January 2021

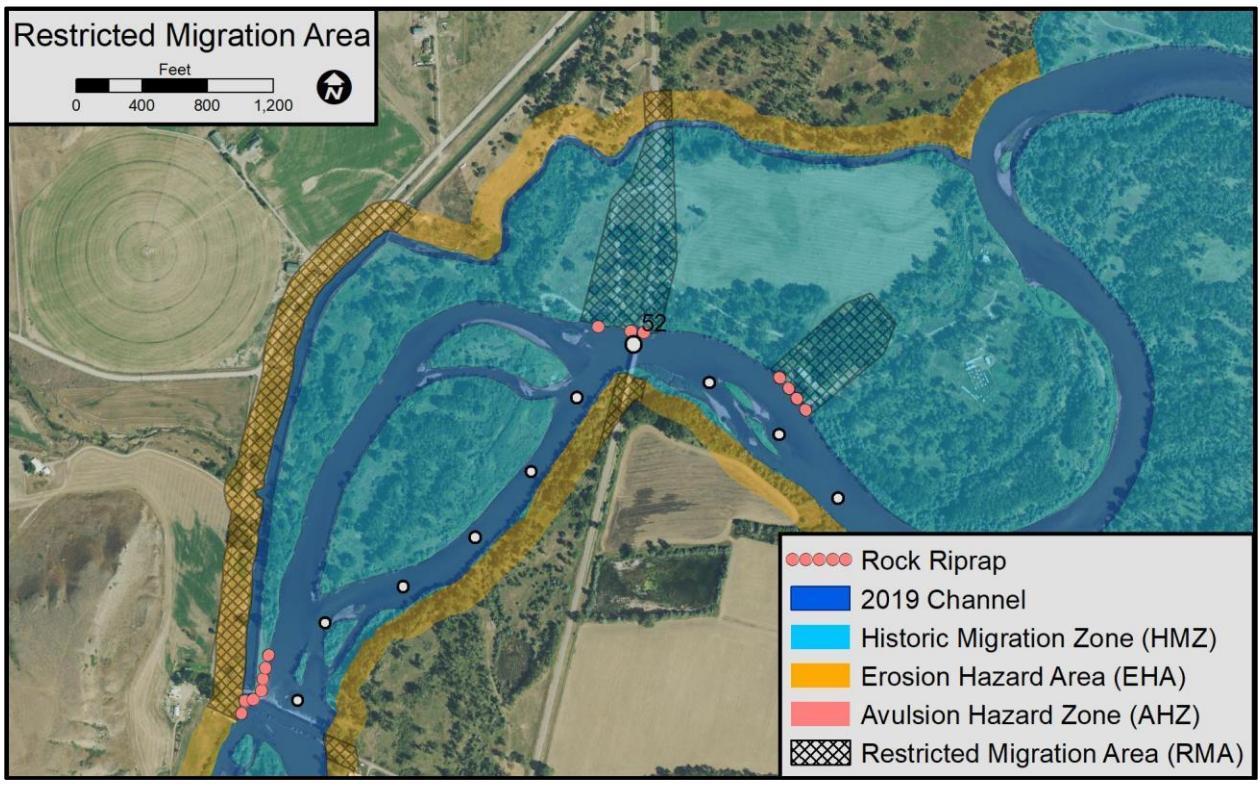
Figure 36 shows an example of Restricted Migration Areas around the Two Leggins Canal.

Figure 36. Restricted Migration Areas Two Leggins Canal.

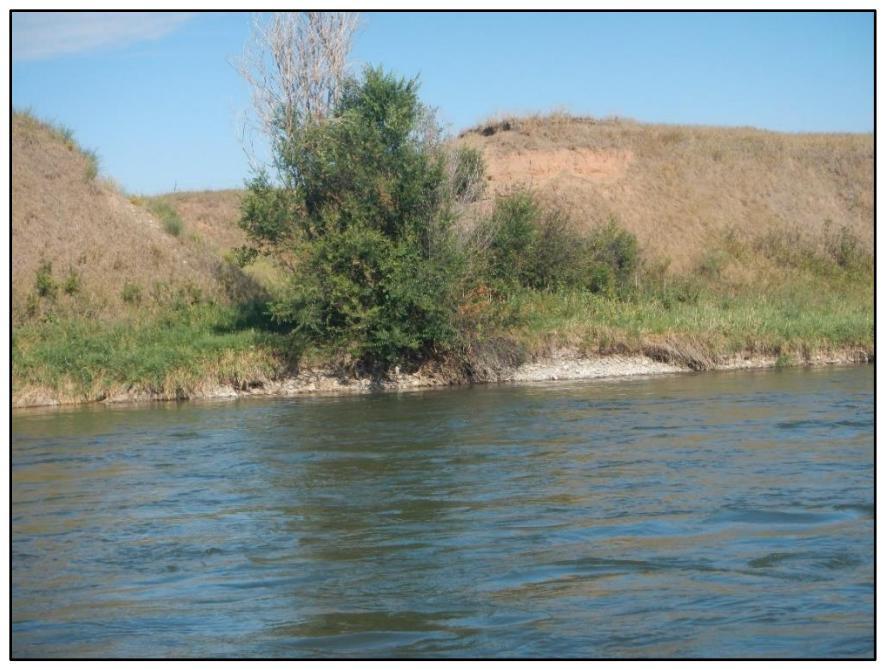
Although Yellowtail Dam has blocked most sediment delivery to Reach BH1, there is still some gravel delivered through bank erosion and from tributaries. The most significant gravel source appears to be from the Red Cliffs (RM 81.4), where gullying of the terrace has delivered coarse sediment to the river (Figure 40), which has downcut through the terrace, enters the Bighorn along the Red Cliffs and similarly delivers gravels which could prove to be important for spawning habitat sustainability in this sediment-starved reach.

Figure 40.Coarse sediment delivered via terrace gullying below Grapevine Creek, RM 81.4.

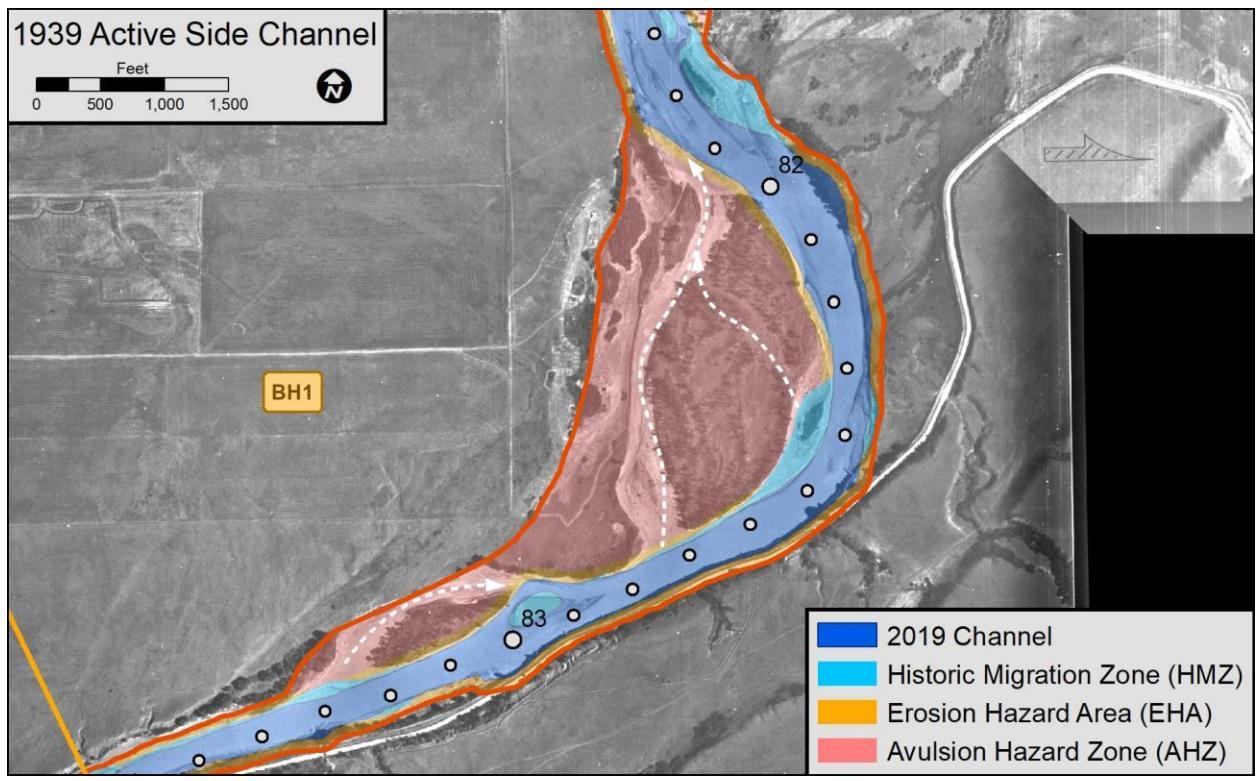
Most of CMZ in Reach BH1 is mapped as avulsion hazard area, where floodplain swales are continuous and un-perched, indicating their potential for reactivation during floods. Several avulsion risk areas capture channels that were active prior to dam completion (Figure 41). One avulsion event was mapped in this reach; it occurred between 1954 and 1979 when a new channel cut through an island just upstream of the Three Mile Access (Figure 42).

Figure 41. 1939 aerial image showing active side channel that is now abandoned but remains in the CMZ due to its potential for reactivation.

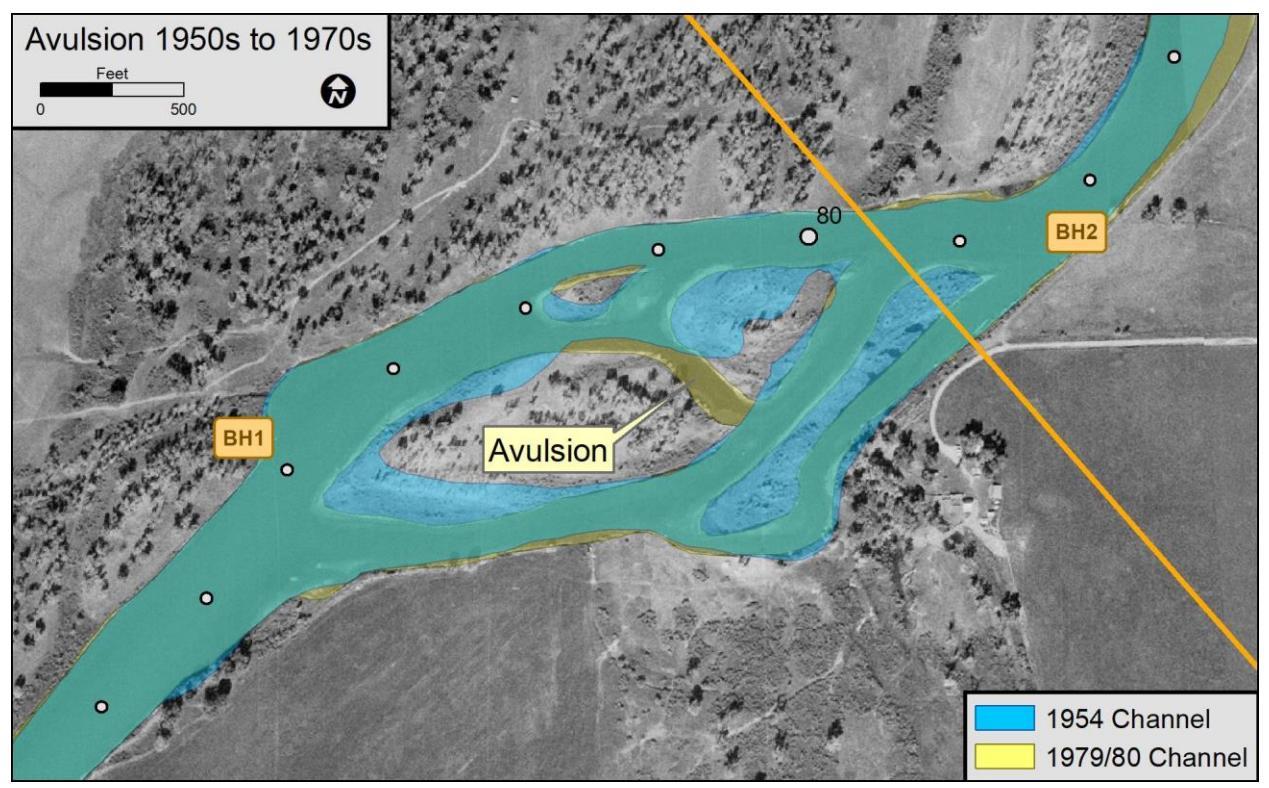
Figure 42. Avulsion upstream of Three mile access.

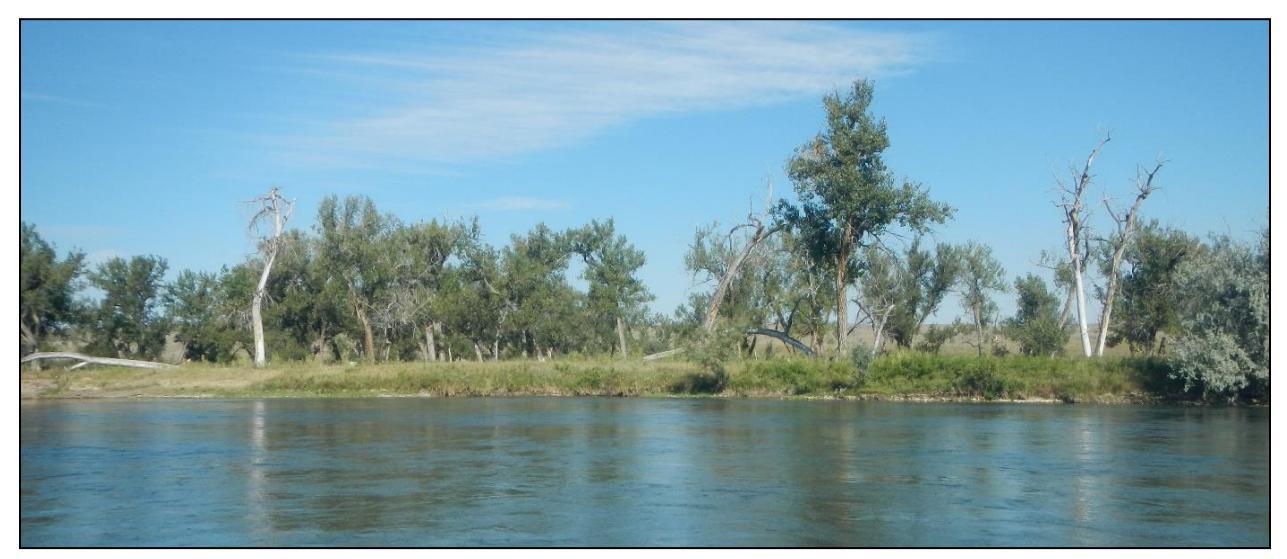
One concern with the lack of geomorphic disturbance in Reach BH1 is the total lack of riparian recruitment on the floodplain; most cottonwoods are mature and becoming increasingly decadent, with few young trees to take their place (Figure 44). Russian olive is common and commonly forms thick stands on the streambanks. One positive observation in the CMZ mapping is the local recruitment of gravels from terraces, floodplain surfaces, and via tributaries; this will contribute at least some spawning gravels to the reach, helping to mitigate future inevitable gravel depletions due to the upstream trapping of sediment in Bighorn Lake (Figure 45).

Figure 44. Aging cottonwood forest, Reach BH1.

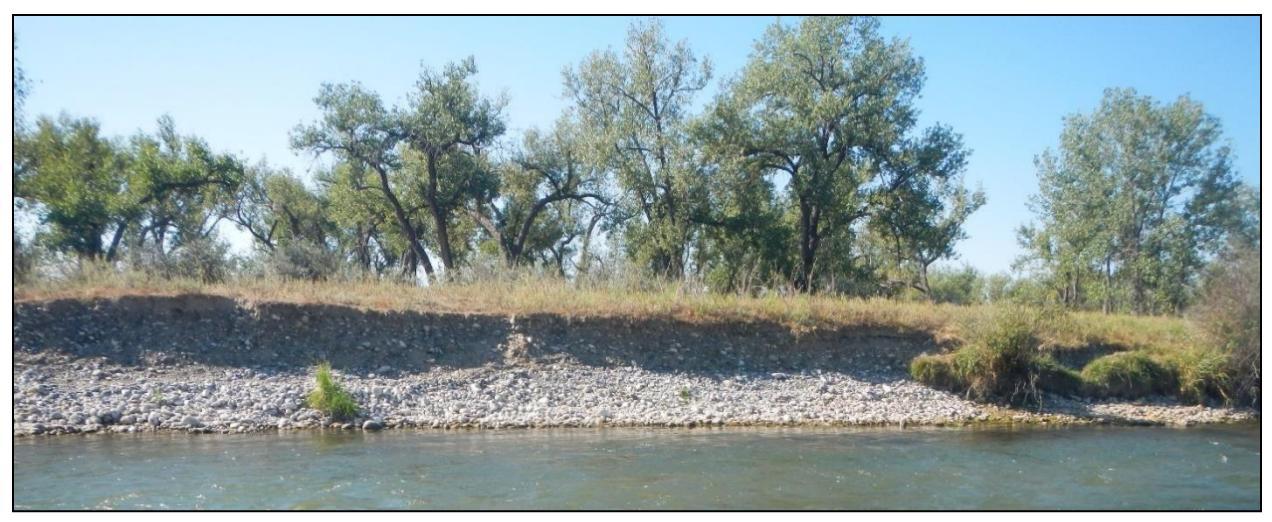
Figure 45. Gravel/cobble alluvium in historic floodplain that provides good spawning substrate to river.

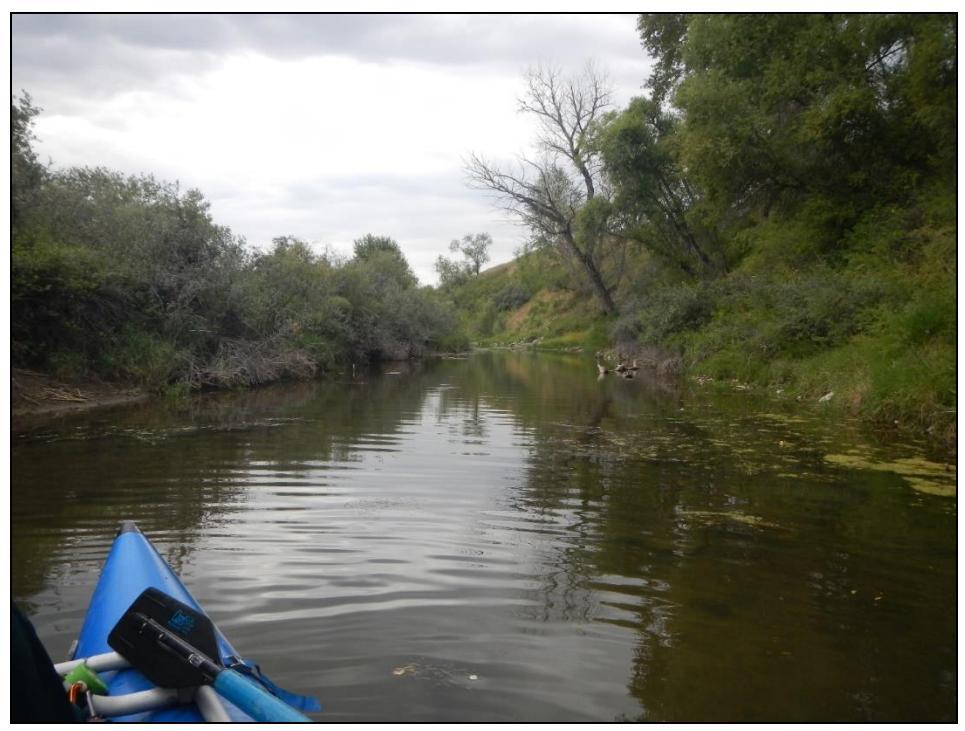
Figure 47. View upstream of remnant 1950s channel below Carol's Run, Rm 78.2.

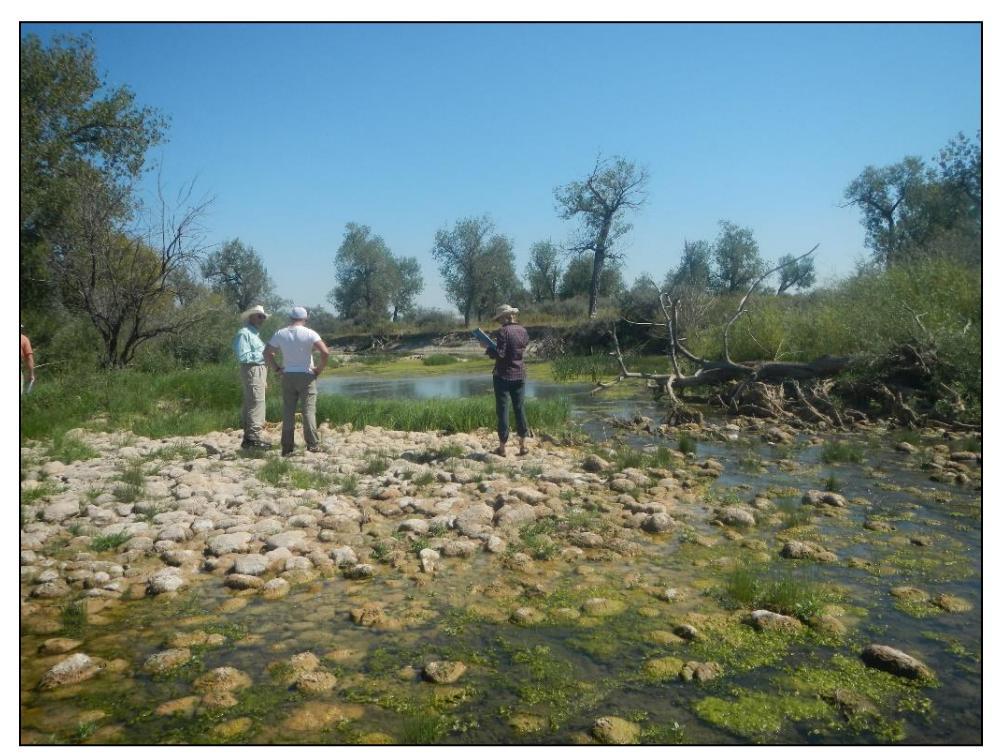
Figure 48. View downstream of the entrance into Juniper Channel, slated for reactivation.

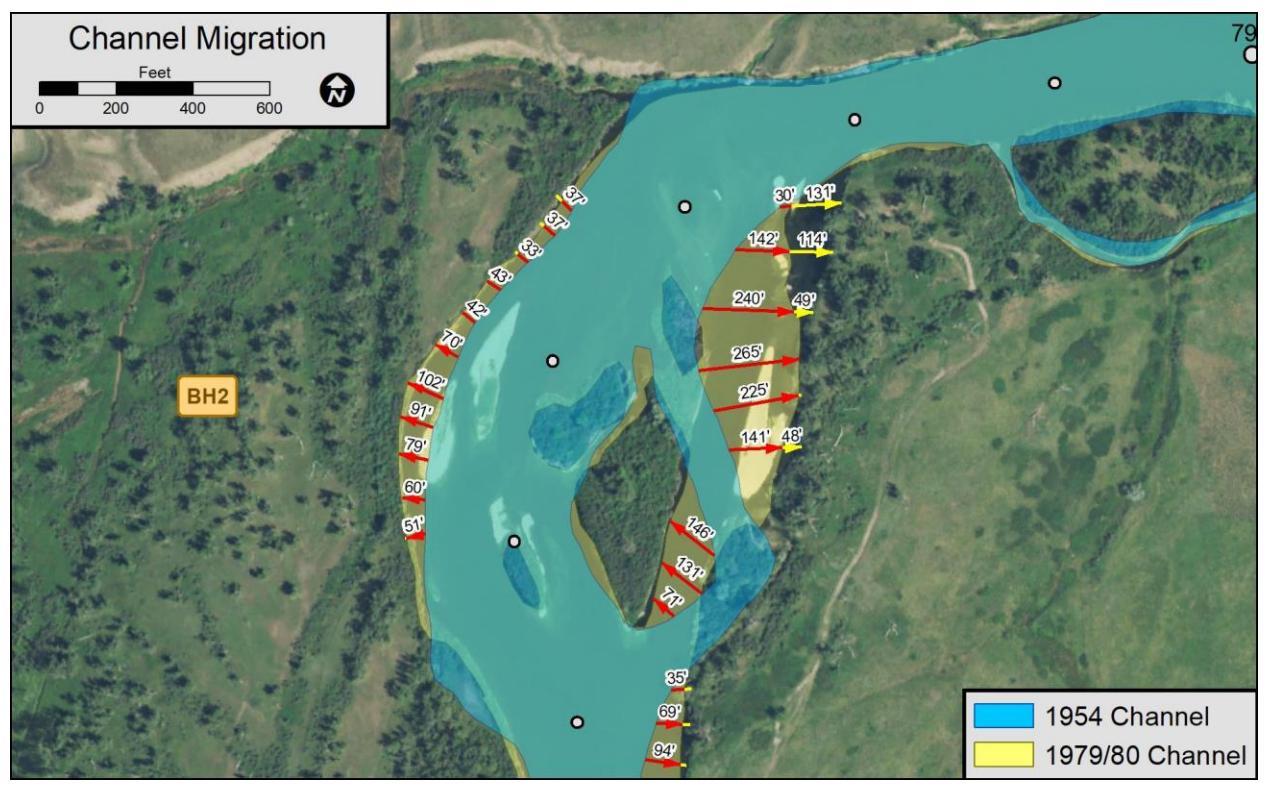
For the Post-Yellowtail Dam timeframe captured in the imagery (1979/80-2019), Reach BH2 has an average migration rate of 1.0 feet per year as measured at 42 sites. The maximum 1979/80-2019 migration distance measured is 131 feet near Snag Hole at RM 79.4 (Figure 49). The erosion hazard buffer width in Reach BH2 is 96 feet, with a buffer of 79 feet along the high erodible bluffs.

Figure 49. Eastward channel movement near Snag Hole showing banklines from 1954 and 1979 on 2019 imagery.

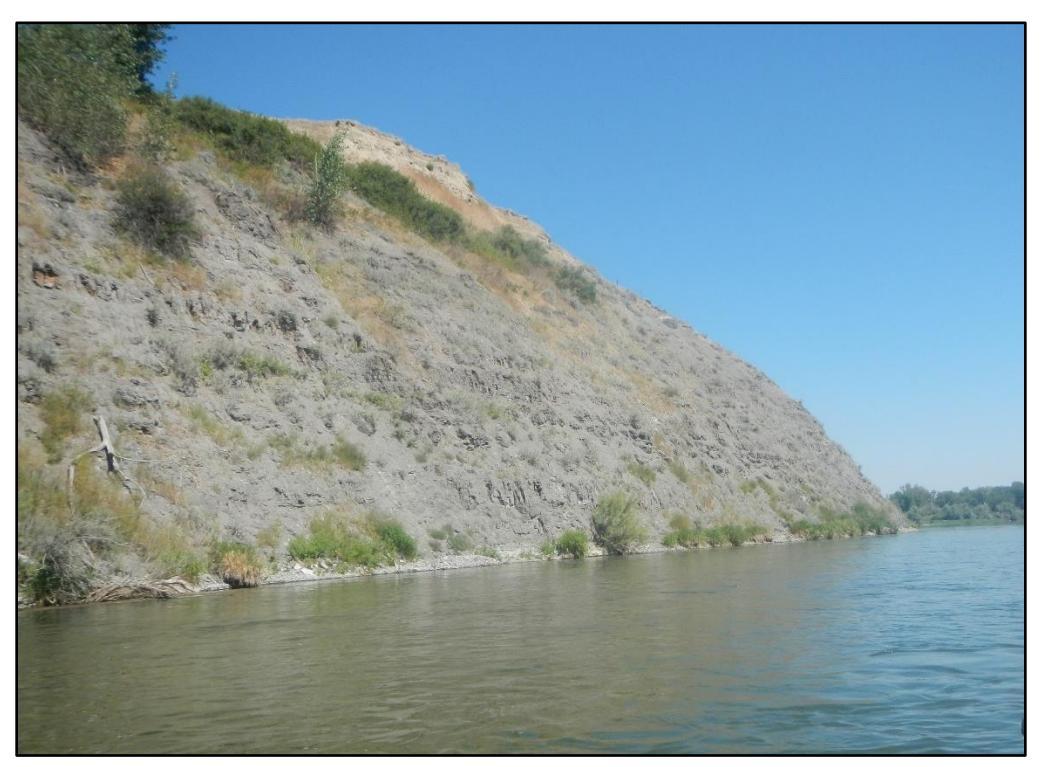
In Reach BH2 the river tends to follow the west margin of the floodplain which is comprised of Cretaceous-aged Mowry shale in the upper portion of the reach and Belle Fouche Shale below RM 71 (Figure 50; Vuke et. al, 2007).

Figure 50. Gray cliffs of the Cretaceous age Mowry Shale, a source of largely fine sediment.

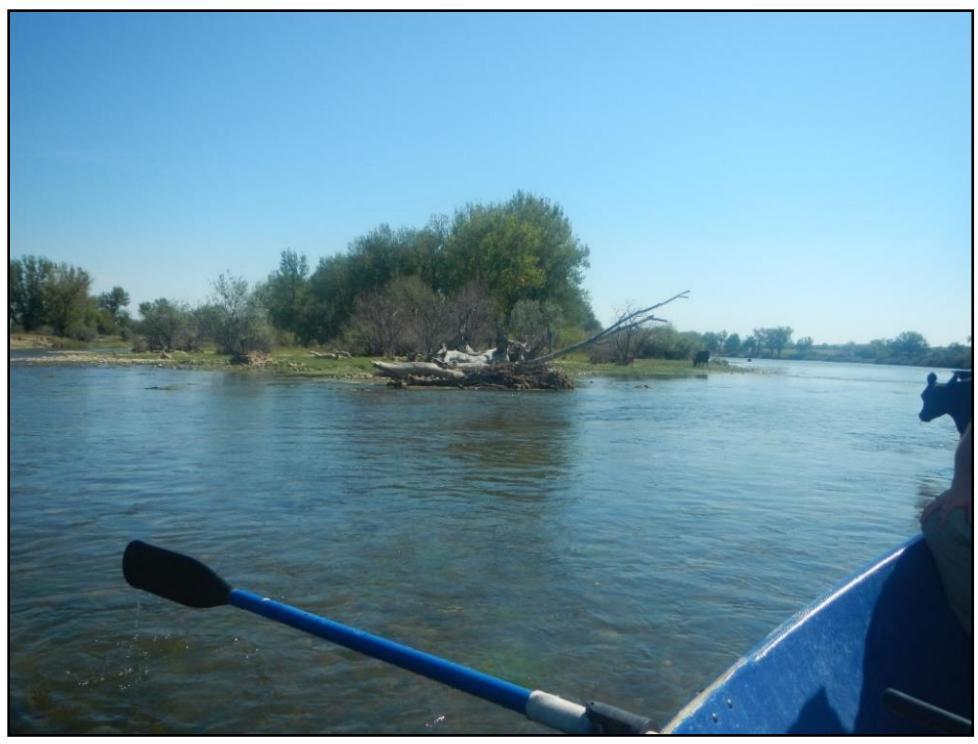
Reach BH2 shows evidence of more disturbance relative to Reach BH1 upstream. Although large wood is still relatively rare in the channel, it does locally affect geomorphology by promoting flow splits at the heads of islands (Figure 51). One positive aspect of the bedload movement and associated geomorphic disturbance in this reach is the presence of a few cottonwood seedlings (Figure 52). Although these cottonwoods will be prone to scour by high flows or ice, the survival of any seedlings will help sustain the Bighorn River cottonwood forest. Both Russian olive and Tamarisk (salt cedar) are common in the reach and may eventually replace cottonwoods without successful cottonwood recruitment.

Figure 51. Large wood accumulation at head of Picture Side Channel, Reach BH2.

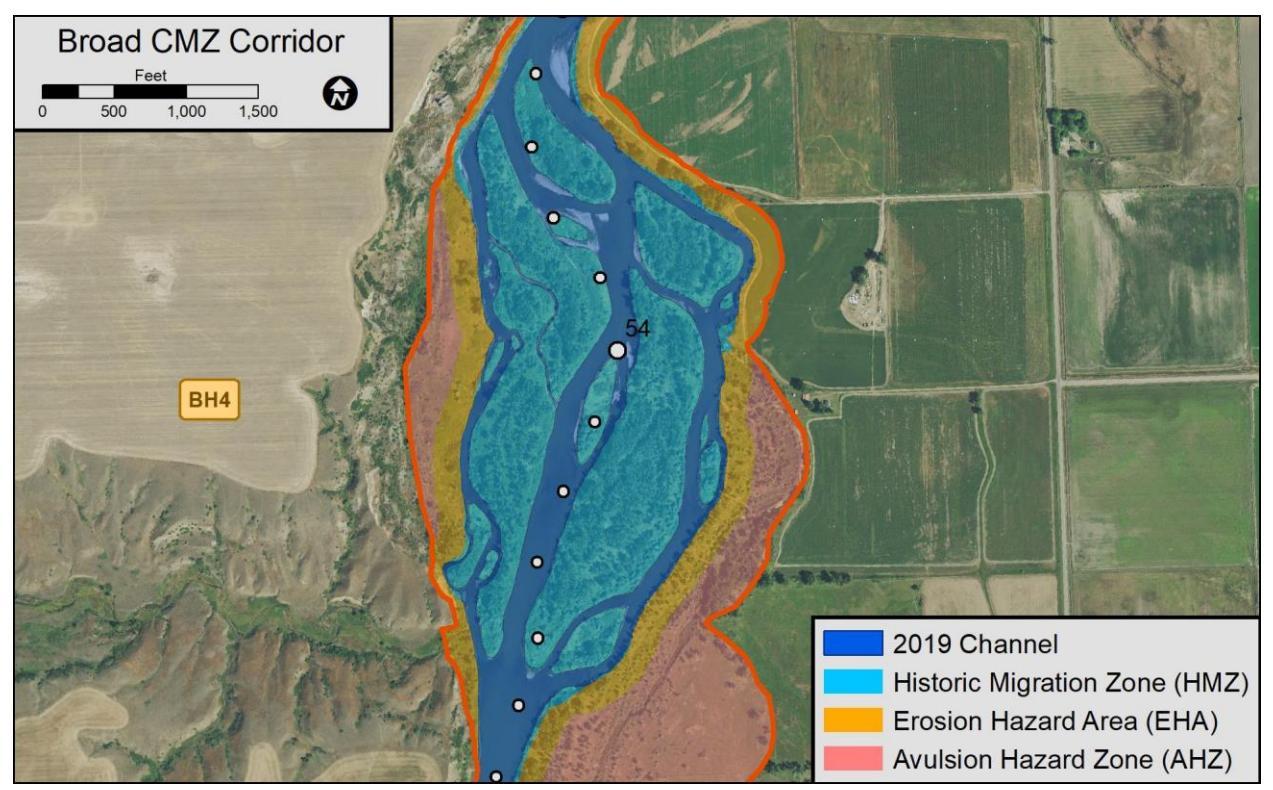
This reach has several complex island segments, creating a relatively wide Historic Migration Zone (Figure 55).

Figure 55. Example of a broad HMZ in area of split flow that supports complex geomorphology and dense riparian forest.
